# Appendix B: Spring Inventory Reports

## 1. Alamo Spring Survey Summary Report, Site ID 12981

Submitted December 23, 2013 by Sky Island Alliance

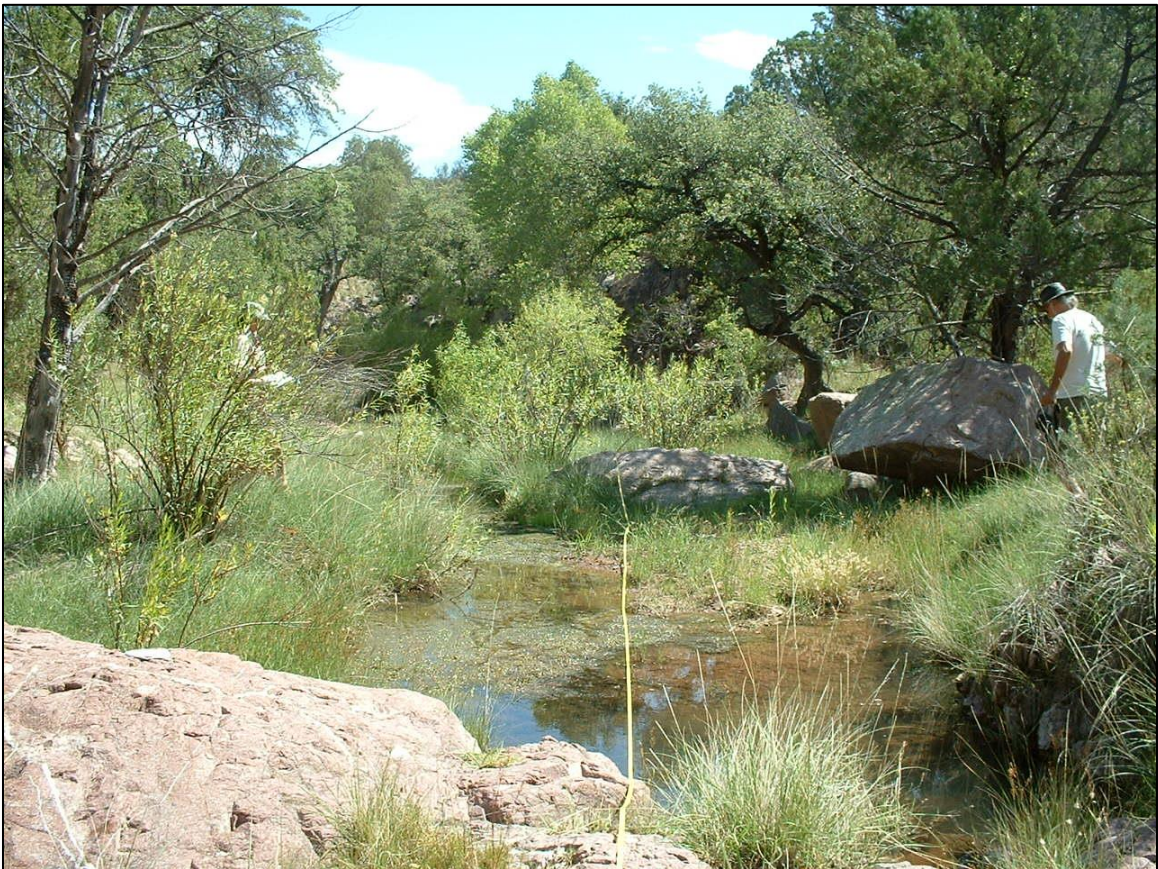
Fig 1.1 Alamo Spring.

**Survey Notes:** The site appears to be in good ecological condition, with slight evidence of grazing. There is an old pipe .5 km from the spring.

Overall, the site condition is good with significant restoration potential and there is low risk.

**Management Recommendations:** This site has high quality habitat and should be flagged for management and protection. Make sure that grazing is managed to preserve the ecological function of the spring, or consider installing fencing.

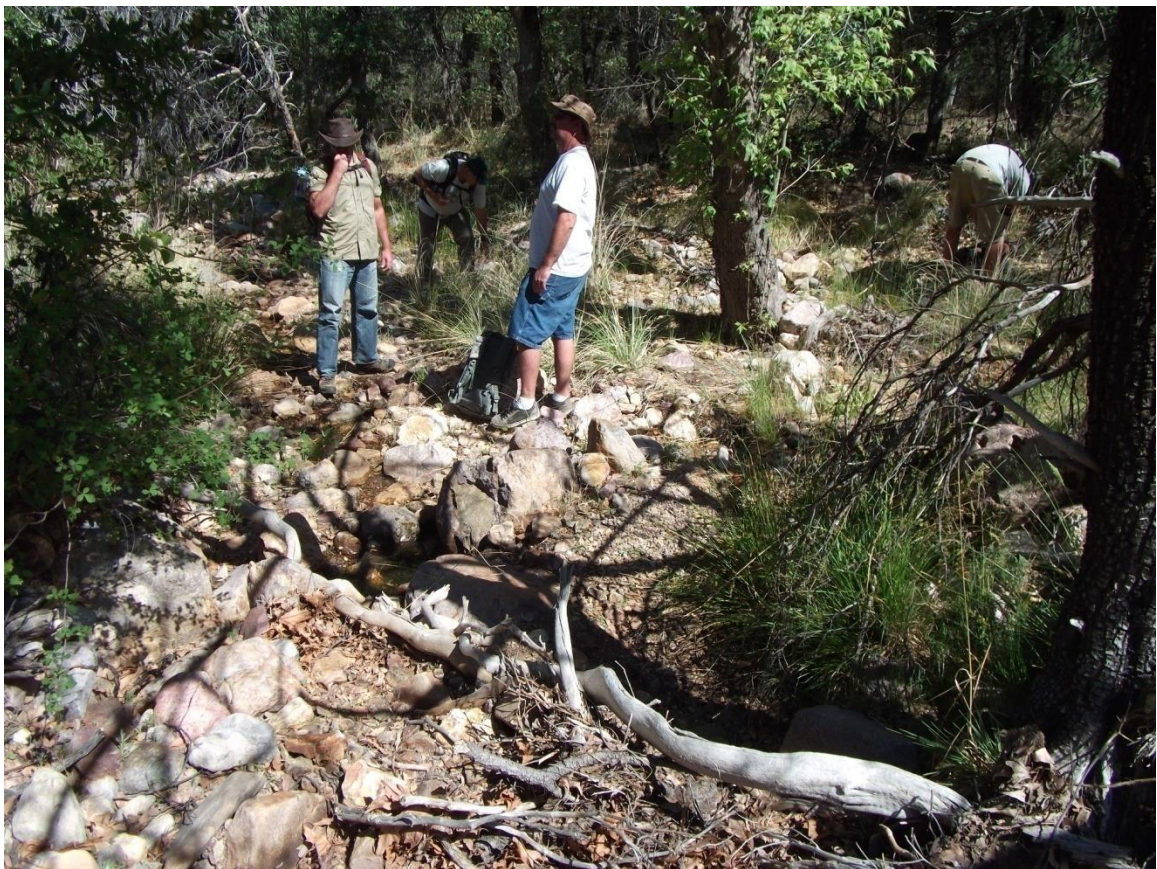
**Fig 8.1 Bear Spring.**

Overall, the site condition is good with significant restoration potential and there is low risk.

**Management Recommendations:** This has been a release site for Tarahumara frogs (*Lithobates tarahumarae*) but they didn't do well. The only amphibian found was *Hyla aremicolor* during our survey. AZGFD is actively reintroducing Tarahumara frogs into Big Casa Blanca Canyon as of August 2012. This site has some potential as a reference site, and is well known among local biologists as a relatively functioning spring site.

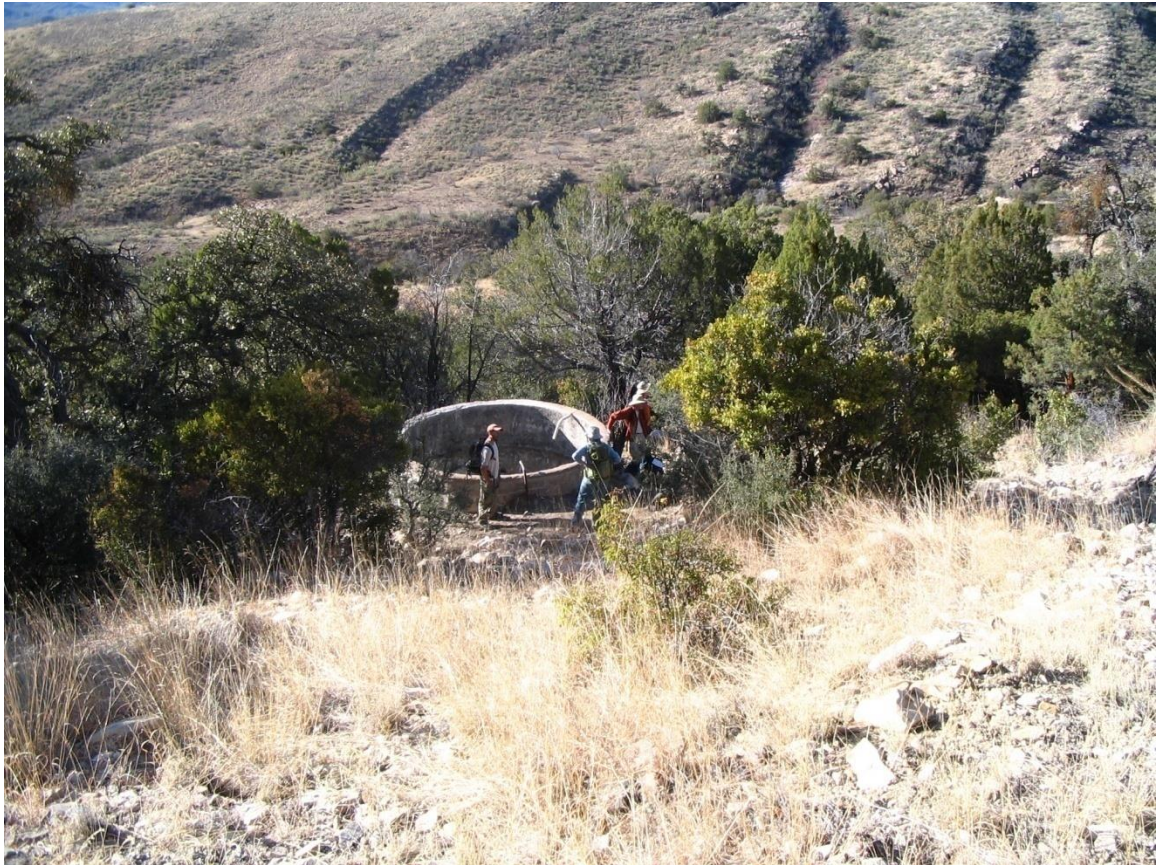
**Fig 9.1 Bear Spring.**

Overall, the site condition is poor with limited restoration potential and there is moderate risk.

**Management Recommendations:** This is a heavily developed site with 100% of water being captured. The area has been degraded by cattle and there is virtually no remaining wetland habitat, aside from tanks and drinkers which are in disrepair. This site was recommended by conservationist Dennis Caldwell as a potential restoration site. It is in a good location to extend Chiricahua Leopard Froge habitat and is historically known to have steady flow. It may be possible to pipe water to a more suitable habitat area down slope.

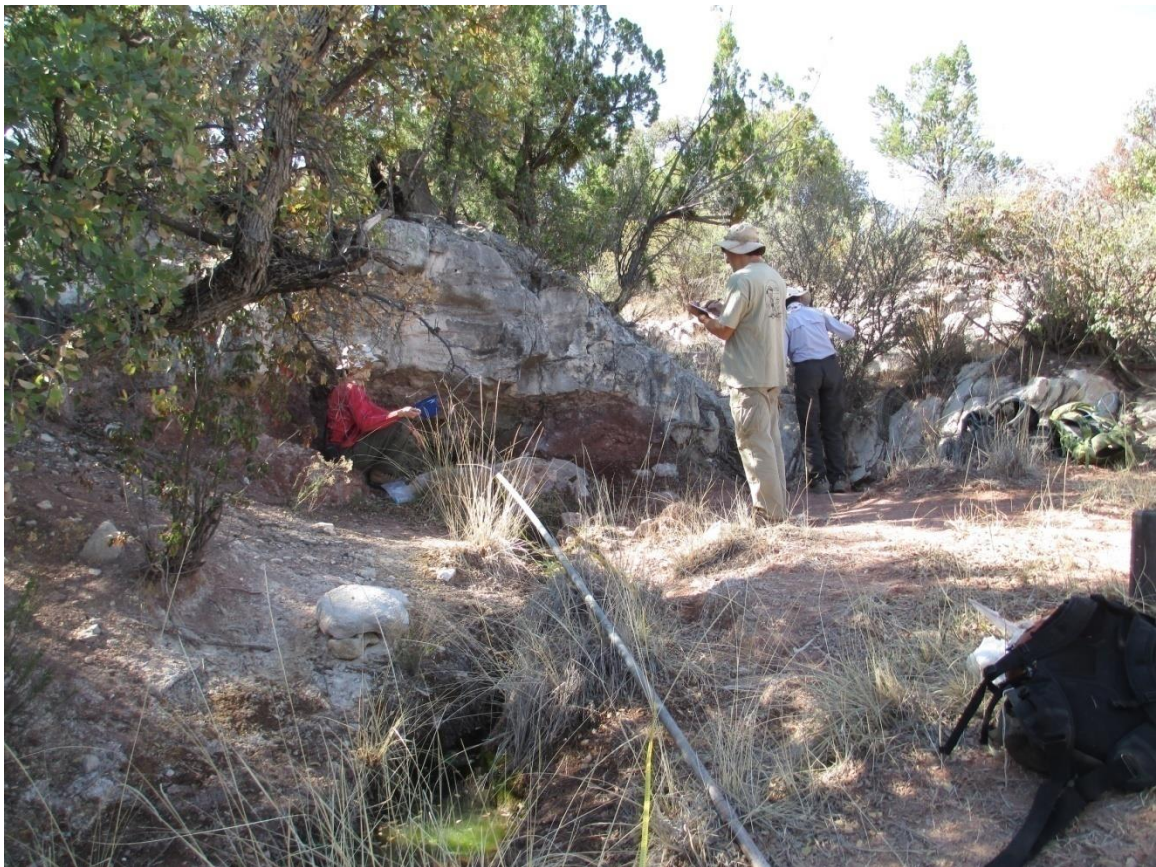
**Fig 11.1 Blacktail Spring.**

Overall, the site condition is moderate with some restoration potential and there is moderate risk.

**Management Recommendations:** There is significant evidence of erosion at the site below the spring wetted area and along the nearby trail. Giant Sedge was present. The neighboring trail and cattle use may be altering channel dynamics. There is a lot of human influence at the spring- a rock that was dynamited and a wall that has the date 1980 etched in it.
