# Appendix B: Spring Inventory Reports

## 1. Alamo Spring Survey Summary Report, Site ID 12981

Submitted December 23, 2013 by Sky Island Alliance

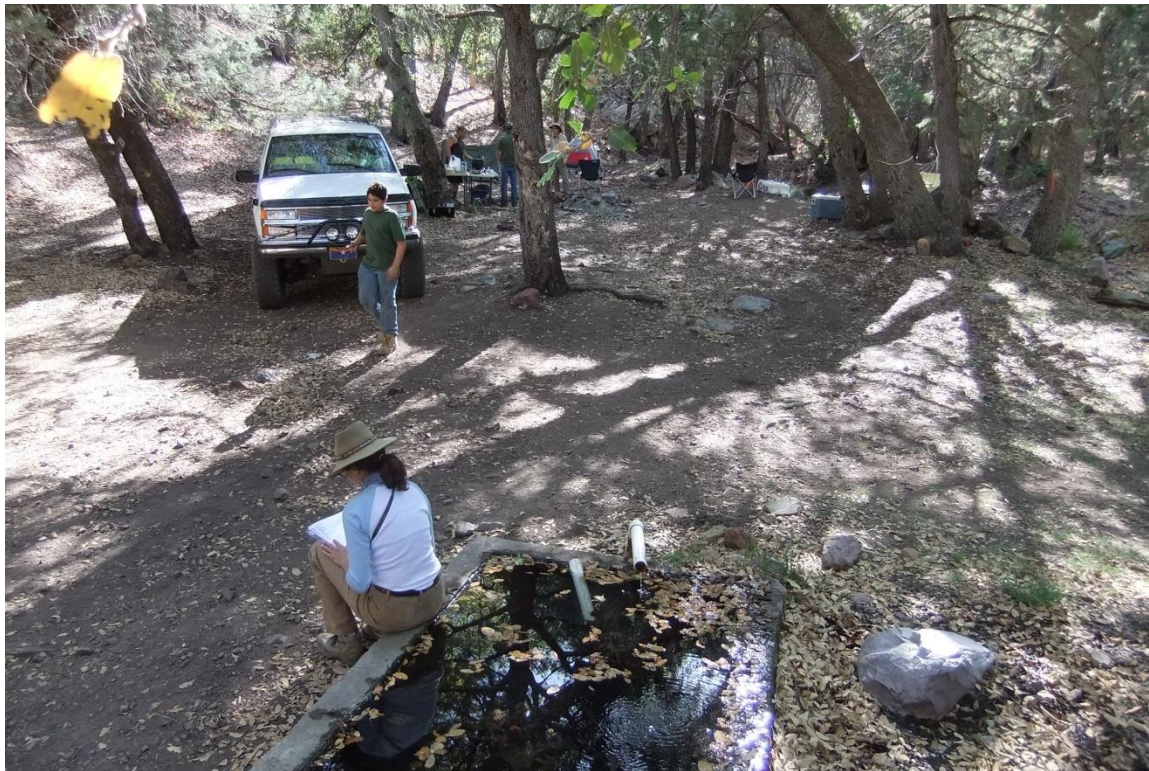
**Fig 2.1 Aliso Spring.**

**Physical Description:** Aliso Spring is a rheocrene spring, boxed spring that is located at a well used campsite.

**Survey Notes:** The surrounding campsite is heavily used and denuded and campers were present. Water is located in the a concrete tank with moist soil around it.

Overall, the site condition is poor with limited restoration potential and there is very high risk.

**Management Recommendations:** Steam is flowing nearby, but not next to the site. There are interrupted segments of flow (ephemeral reaches), but surveyors were unable to determine origin of flow coming out of pipe as there is no evidence of a pipe in the stream.

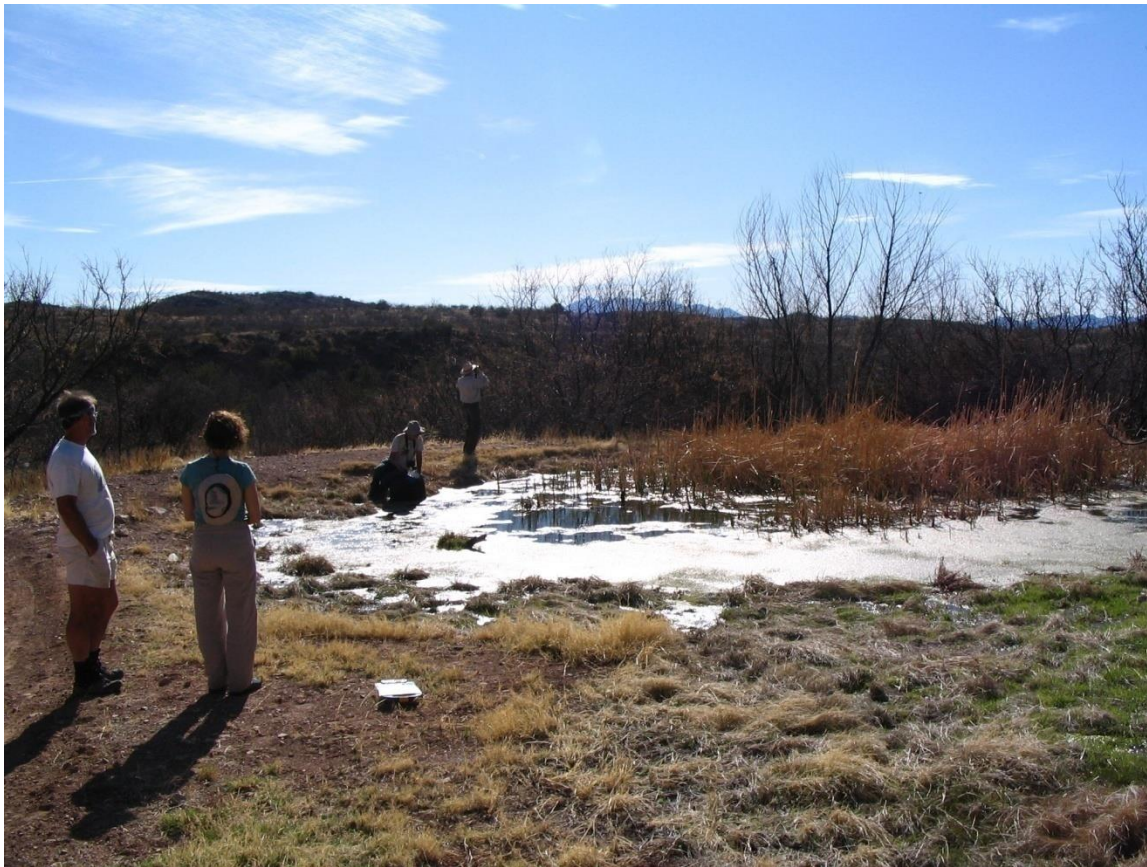
**Fig 3.1 Apache Spring.**

**Physical Description:** Apache Spring is a helocrene spring with a shallow water table accessed with a 3 ft. Culvert pipe. There is a cabin directly adjacent to the well, piped to larger holding tanks. The microhabitat associated with the spring covers 447 m<sup>2</sup>. The distance to the nearest spring is 3453 meters. The site receives approximately 100% of available solar radiation.

Overall, the site condition is poor with limited restoration potential and there is moderate risk.

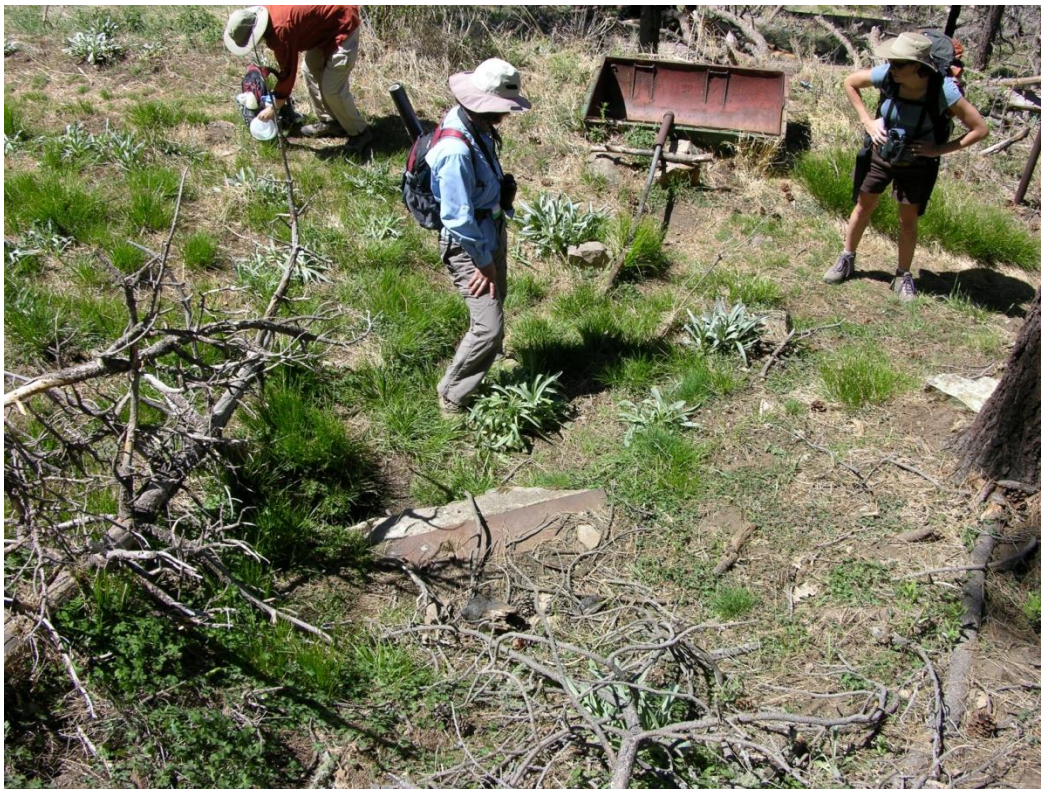
**Fig 4.1 Baldy Spring.**

**Physical Description:** Baldy Spring is a helocrene spring on a relatively steep north/northeast facing slope in close proximity to a mountain pass above the origin of Gardner Canyon drainage. The spring emergence is located under within what appears to be a spring box with concrete over it in a Designated Wilderness Area. The microhabitat associated with the spring covers 35 m<sup>2</sup>. Geomorphic diversity is 0.0, based on the Shannon-Weiner diversity index.

**Survey Notes:** This is a helocrene spring located in an area that was severely burned. There is a well used hiking trail within 2 meters of the spring site and the spring emergence is a small pool of water located under a concrete spring box structure. There is old piping infrastructure going from the spring to a rusted out tank just across the hiking trail. The main microhabitat at this site is a small, very shallow pool of water located directly under the concrete.

Overall, the site condition is moderate with some restoration potential and there is low risk.

**Management Recommendations:** Check for historic flow data to understand the effect the fire has had on the spring. The spring was verified by the FS so it was probably more productive at one time. This spring is of high value for recreation purposes - hikers in the Wilderness- so it would be beneficial to look at the impact the trail and existing spring box structure is having on spring functionality. It would also be beneficial to clean the spring box. Due to the fire, the spring is very exposed and may benefit from native plant restoration to provide more shade and microhabitat shelter.

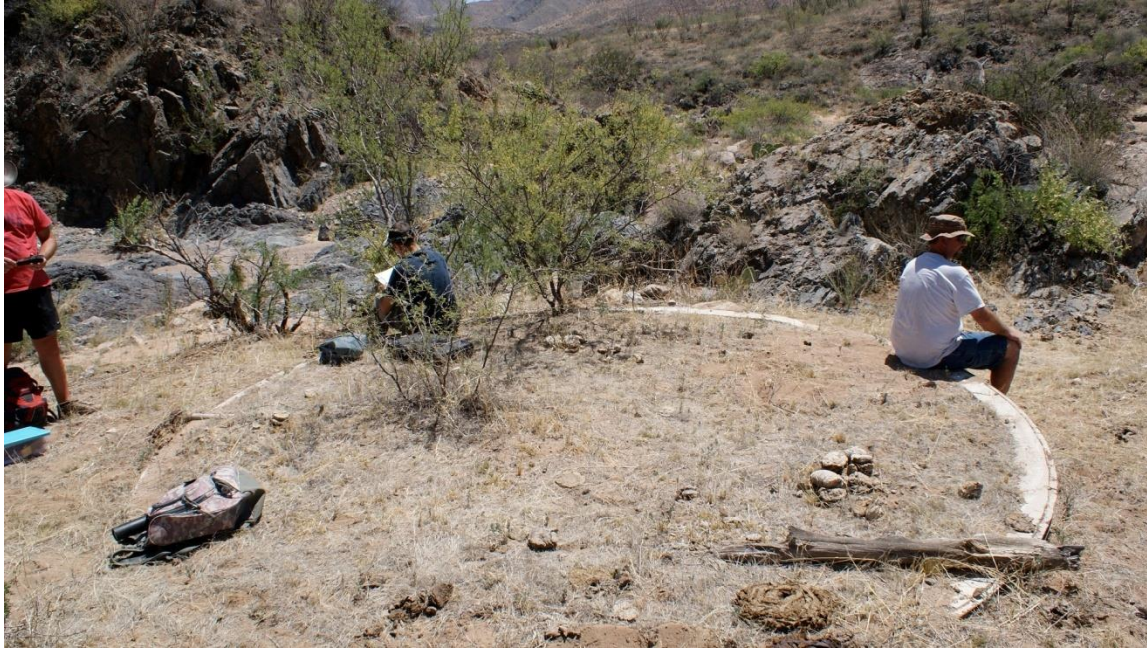
**Fig 5.1 Barrel Spring.**

**Physical Description:** Barrel Spring is an anthropogenic spring. Spring was a 12' diameter stock tank with no storage capacities due to it being full of sediment. The microhabitat associated with the spring covers 144 m<sup>2</sup>. Geomorphic diversity is 0.0, based on the Shannon-Weiner diversity index.

Overall, the site condition is poor with limited restoration potential and there is low risk.

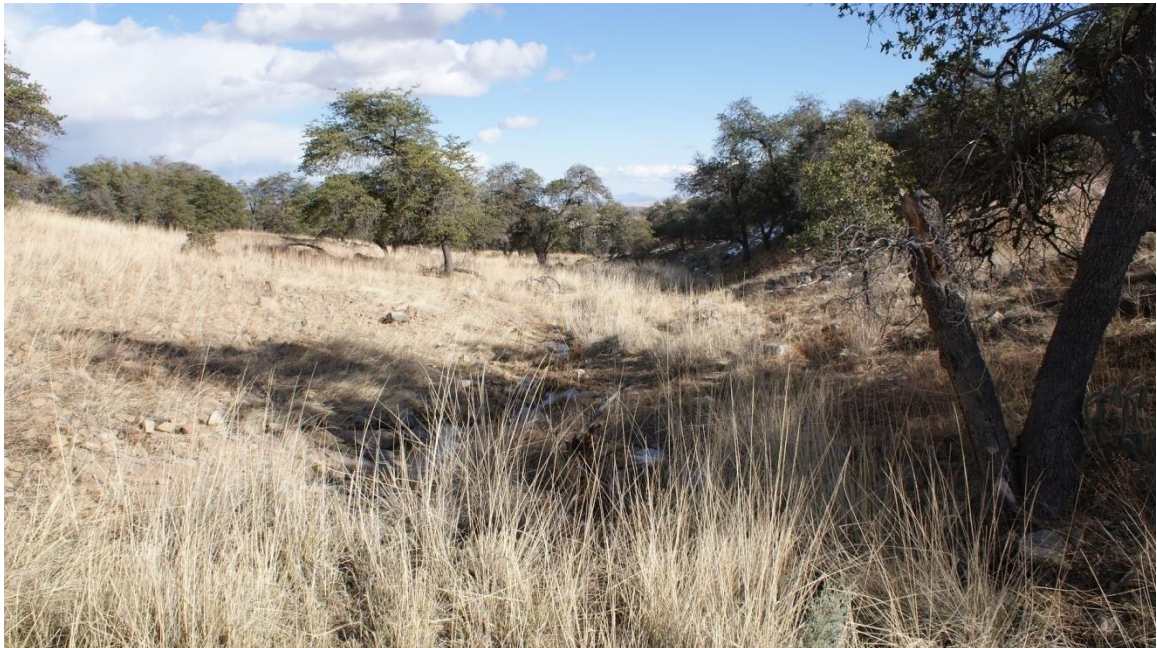
**Fig 10.1 Benton Spring.**

**Physical Description:** Benton Spring is a rheocrene spring. The microhabitat associated with the spring covers 650 m<sup>2</sup>.

**Survey Notes:** The site consists of a series of pools that emerge with a 150 square-meter wet meadow area around the first two pools. The same pattern alternates upstream at least 1/2 mile and downstream for several hundred yards. This site has seen some degradation by cattle, but not as severe as at Line Boy Spring. The flow in the drainage in other sections seems to be runoff from a recent storm instead of permanent water.

Overall, the site condition is good with significant restoration potential and there is low risk.

**Management Recommendations:** This site would benefit from fencing to reduce impacts from herbivory. It would be good to assess the site pre-monsoon to determine flow.

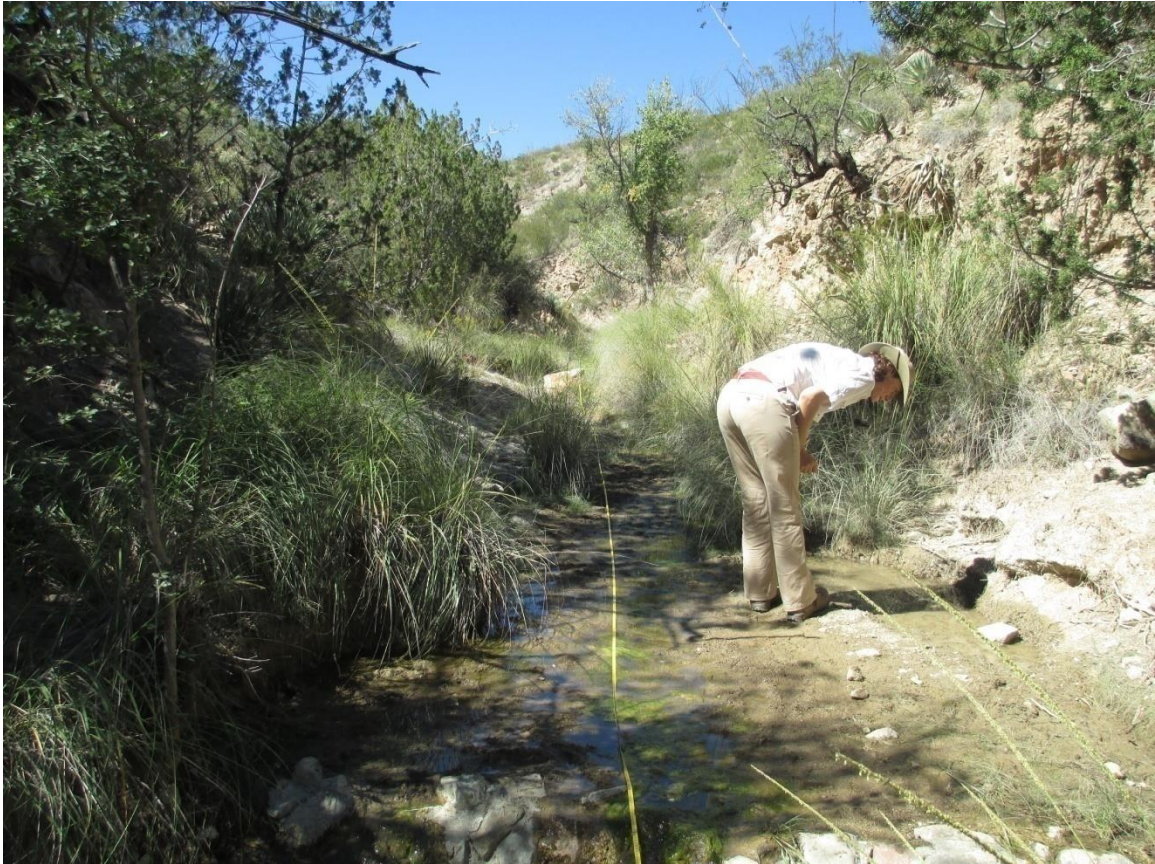
**Fig 12.1 Bootlegger Spring.**

**Physical Description:** Bootlegger Spring is a rheocrene spring, located in a small narrow canyon in Oak-juniper woodland above a major tributary drainage to Cienega creek. The total area of the observed microhabitat is 400 meters-squared. The distance to the nearest spring is 422 meters.

**Survey Notes:** There is standing water present and piping infrastructure that appears to be freshly repaired coming from a small dam, but it is unclear where the piping is going. There is a dry holding tank about 200m down channel, and signs of cows in the wetted habitat.

Overall, the site condition is good with significant restoration potential and there is low risk.

**Management Recommendations:** Although geomorphology seems to be mostly intact there is extensive modification to the flow with a small constructed rock dam across the channel that has piping infrastructure coming out of it. There is an empty concrete tank downstream with dead/dry standing cattails in it, but piping to it appears to be non-functioning. Looks like there was recent repair on piping nearest the source, but it is unclear where this is going. Notably there are no invasive species and the site is relatively protected from roads/trails. This is a very nice rheocrene site that may benefit from infrastructure removal if it is no longer in use.

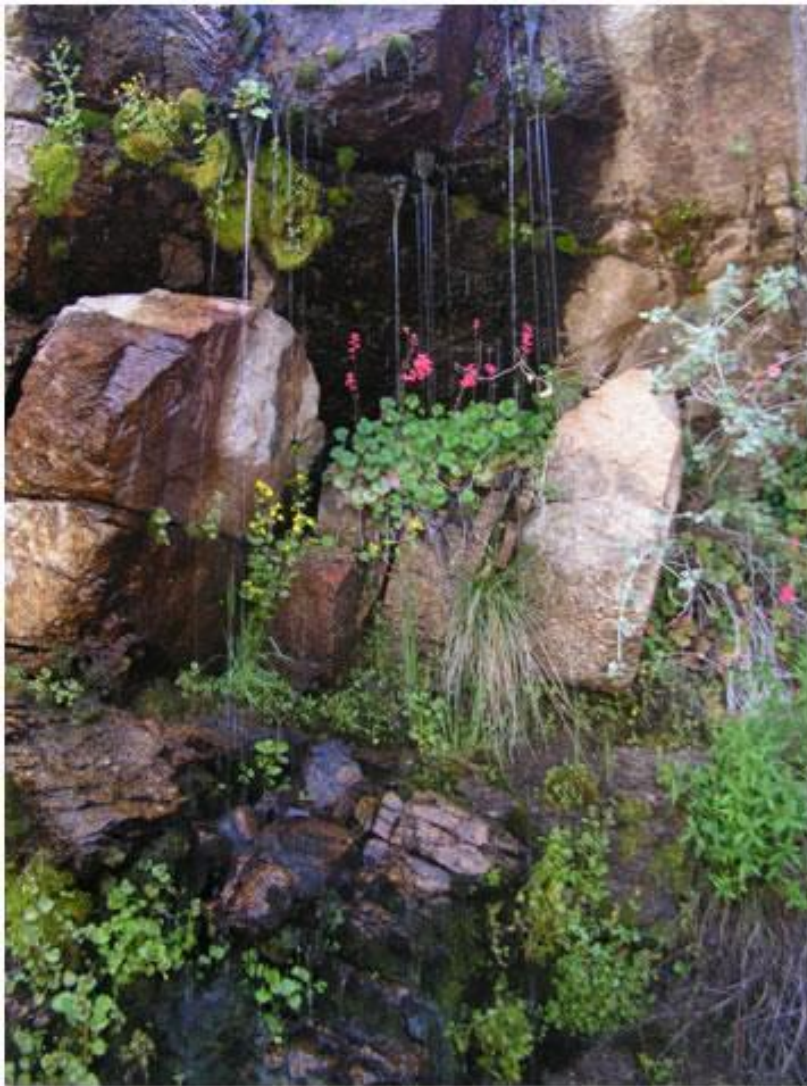
Bug Spring is a rheocrene. The distance to the nearest spring is 1949 meters. The site receives approximately 94% of available solar radiation, with 6723 Mj annually.

**Survey Notes:** This survey was part of a training session early on in the process. There is a pool formed from boulders in the channel that is 3m deep. The trees have some damage due to fire. There was algae covering the top pool, but the bottom pool had none. The channel has a sandy bottom. There is some piping down below the source that is not being used.

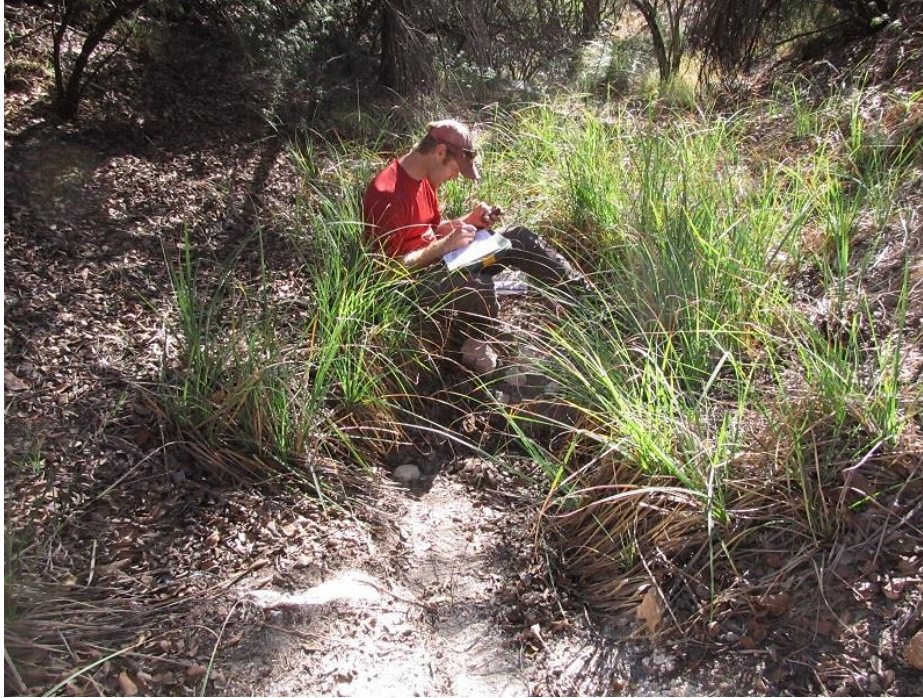
**Fig 14.1 Burro Spring.**

**Physical Description:** Burro Spring is a rheocrene/hypocrene spring located in a steep canyon dominated by Pinyon pine and juniper. The spring was dry but had patches of carex surrounding dry pools. There were also travertine deposits surrounding the spring, particularly a little higher in the drainage. The microhabitat associated with the spring covers 306 m<sup>2</sup>.

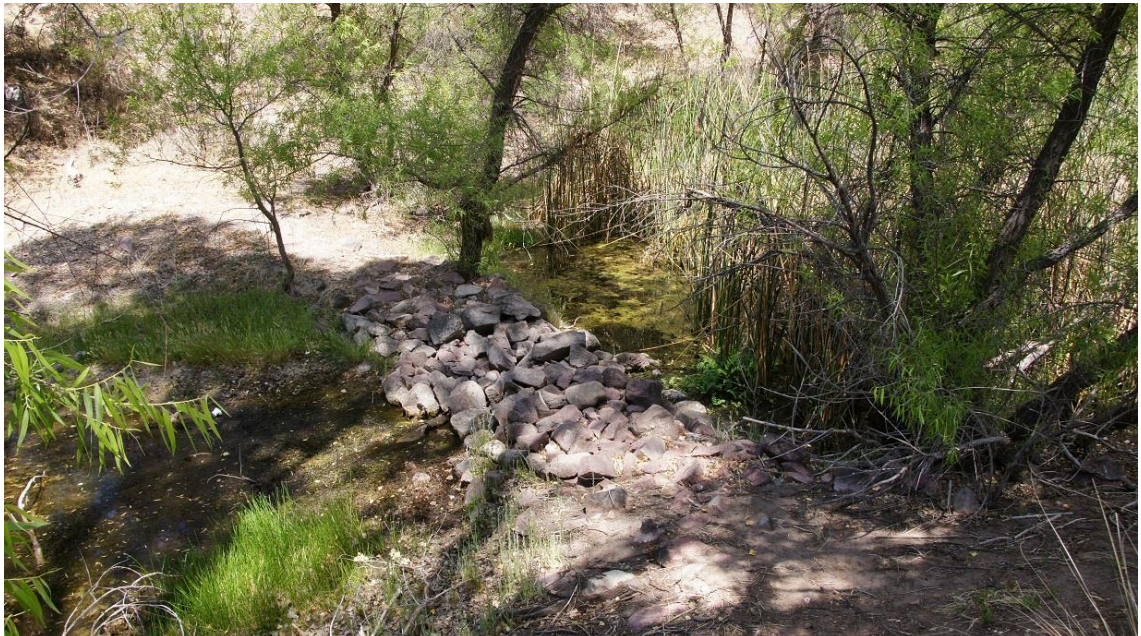
**Fig 16.1 Collins Spring.**

**Physical Description:** Collins Spring is a limnocrene perennial spring adjacent to Parker Canyon Lake. It is a large, sunken wetland, and has possibly been excavated. There is a well house and maintenance facility adjacent to the spring. The microhabitat associated with the spring covers 1,989 m<sup>2</sup>.

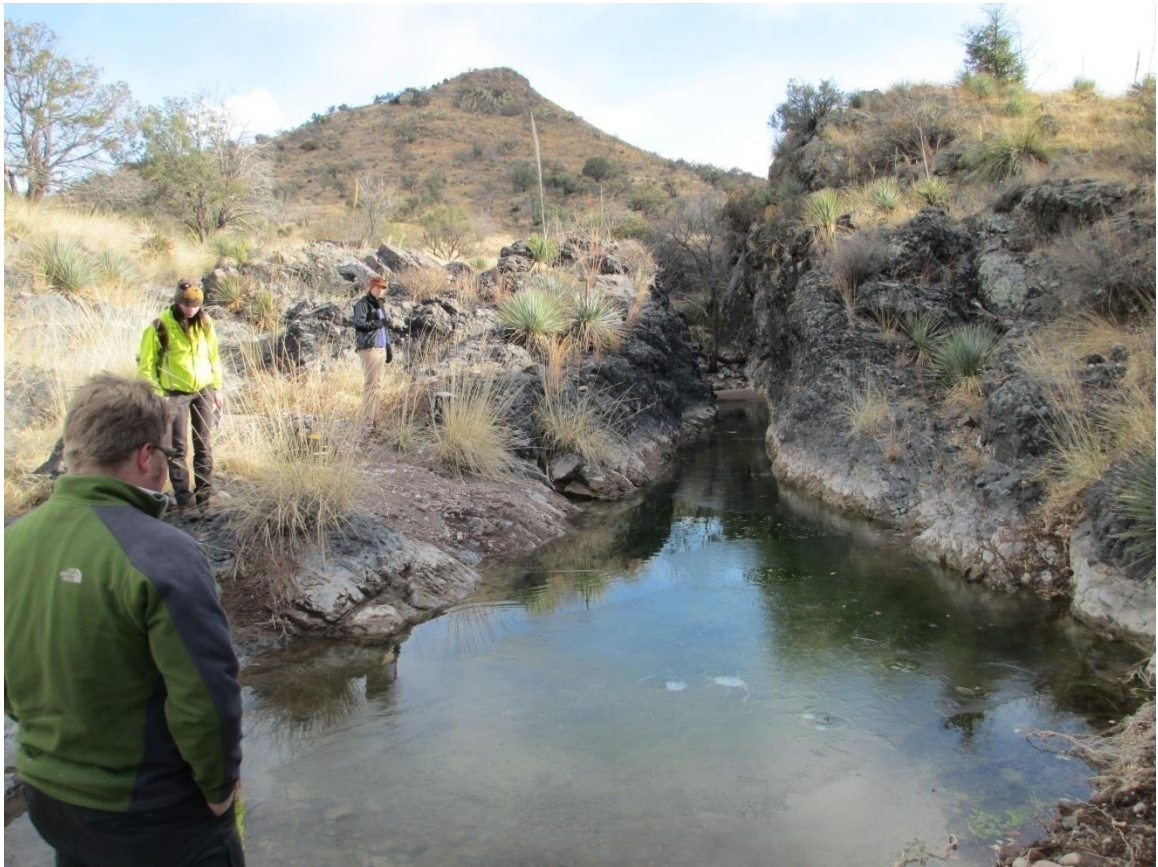
**Fig 17.1 Copper Mountain unnamed.**

**Physical Description:** Copper Mountain unnamed is a rheocrene spring with a large pool (approx 50'x8' by 10' deep). The distance to the nearest spring is 1421 meters.

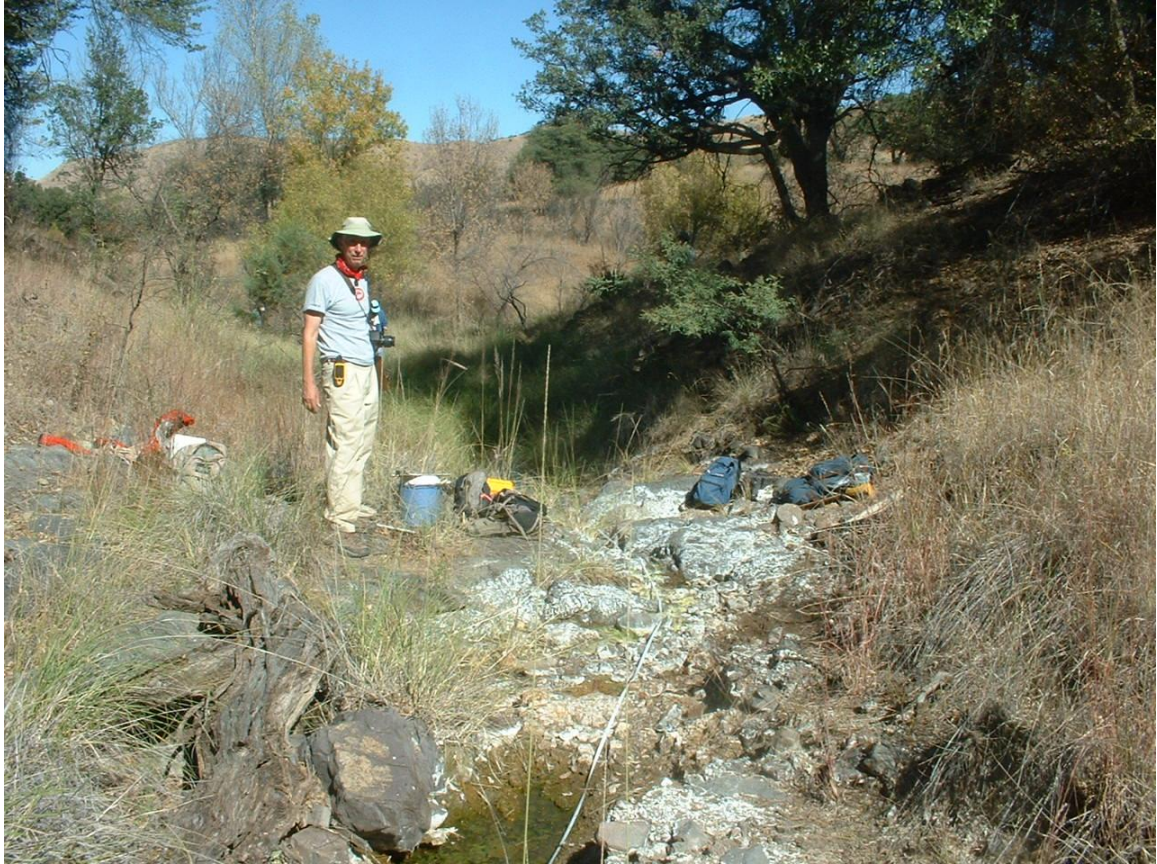
**Fig 18.1 Cott Tank.**

**Physical Description:** Cott Tank is a rheocrene spring that discharges from beneath a mossy rock and flows into a channel. The entire site has an exclosure to keep cattle out and to protect native plants. The exclosure was constructed in 1996. There is a dam upstream of the spring that has been silted in. The microhabitat associated with the spring covers 450 m<sup>2</sup>.

**Survey Notes:** Cott Tank Spring has been exclosed from grazing since 1992. The site was in good condition with no evidence of recent human activity. Something has been browsing the *Juncus* heavily.

Overall, the site condition is good with significant restoration potential and there is low risk.

**Management Recommendations:** Surveyors did not note any management recommendations.

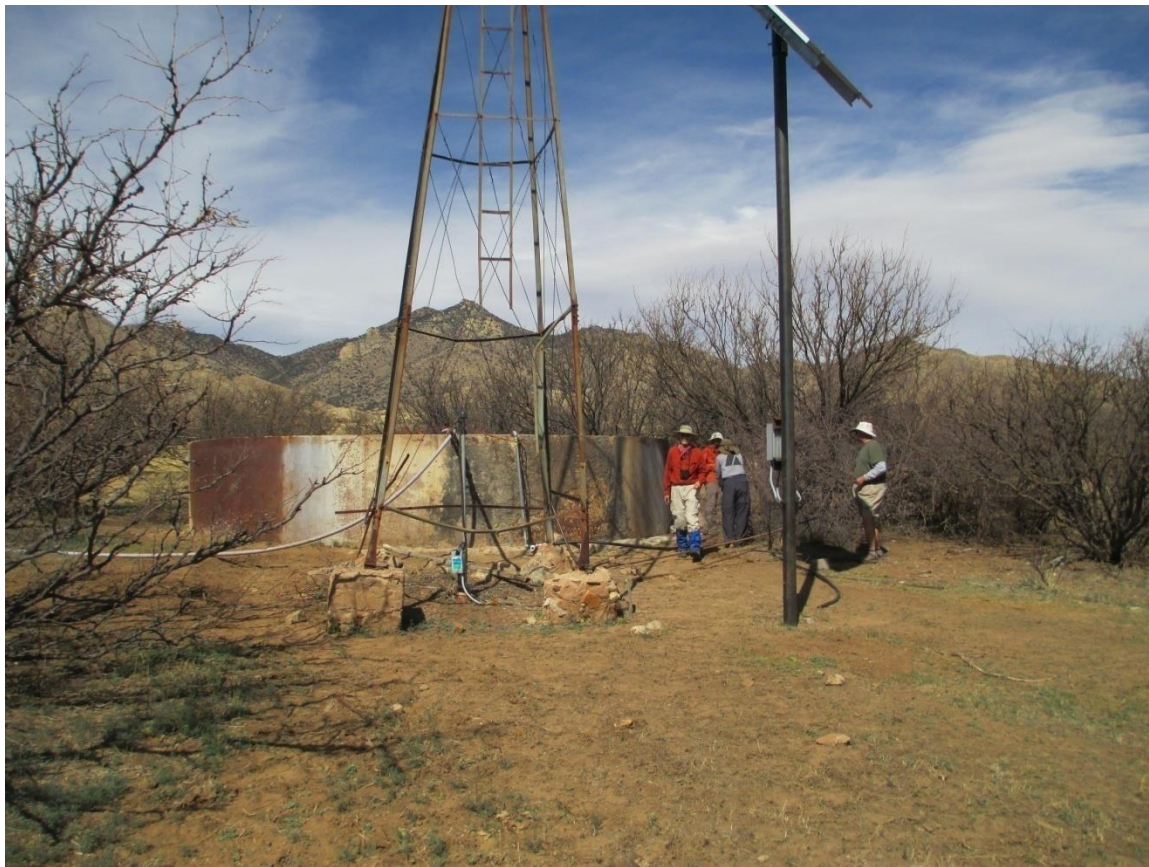
**Fig 19.1 Cottonwood Spring.**

**Physical Description:** Cottonwood Spring is a rheocene spring. The site now contains an 8.5 meter diameter developed cattle tank with solar panels. The microhabitat associated with the spring covers 63 m<sup>2</sup>. Geomorphic diversity is 0.0, based on the Shannon-Weiner diversity index.

Geomorphology condition is poor with limited restoration potential and there is high risk.

Habitat condition is poor with limited restoration potential and there is high risk.

Overall, the site condition is poor with limited restoration potential and there is moderate risk.

**Management Recommendations:** The site consists of a windmill with solar panels. Water is pumping into a large tank with an adjacent cattle guzzler. The adjacent drainage has suffered noticeably. The water has also been pumped through unsightly plastic tubing all the way to and from Goat Well 2/3 mile away. Historically the spring was likely in the adjacent riparian area. The site may benefit from putting water back into the ground in the adjacent riparian area to restore some wetted/riparian habitat, but restoration of the spring source to a more natural state does not seem likely.

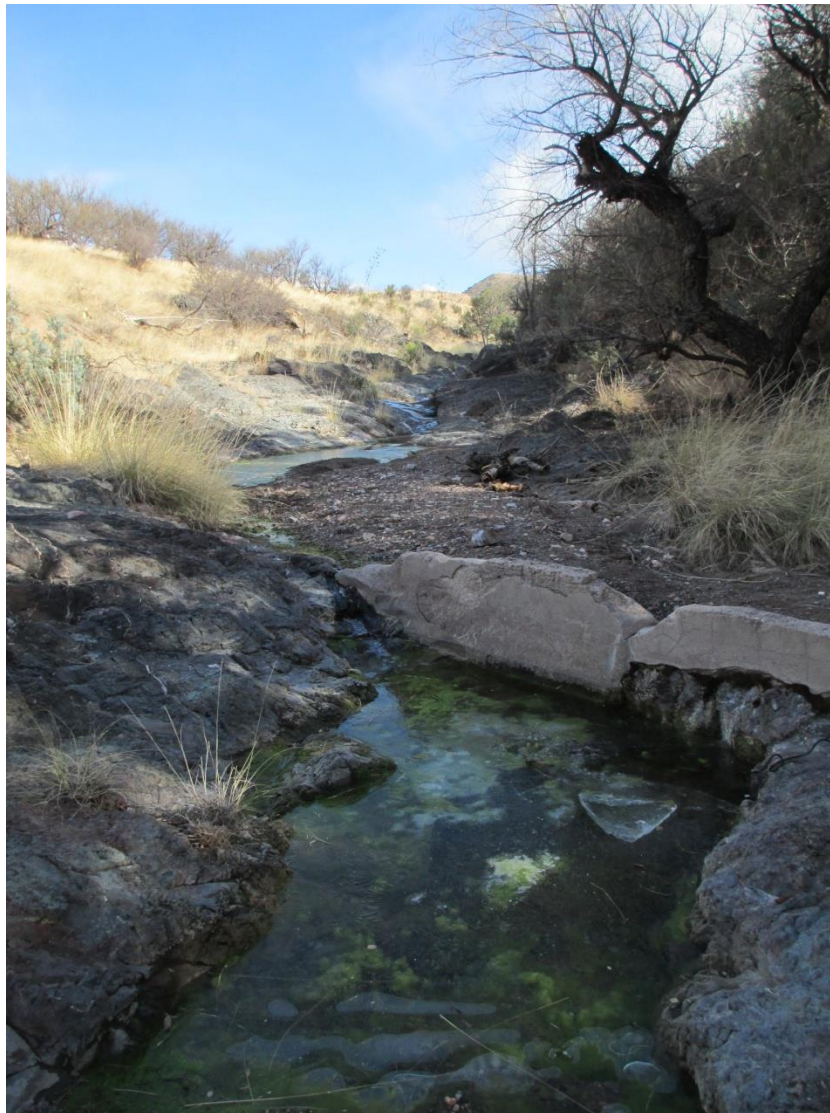
**Fig 20.1 Cottonwood Spring.**

Overall, the site condition is good with significant restoration potential and there is negligible risk.

**Management Recommendations:** The spring is in a mostly natural state. There are non-functional pipes, drinkers and a concrete dam on site. There is moderate herbivory by cattle. Spring is in a steep bedrock channel with little wetland or soil formation likely too much erosion from natural flooding. Several pools and sources of flow are present.

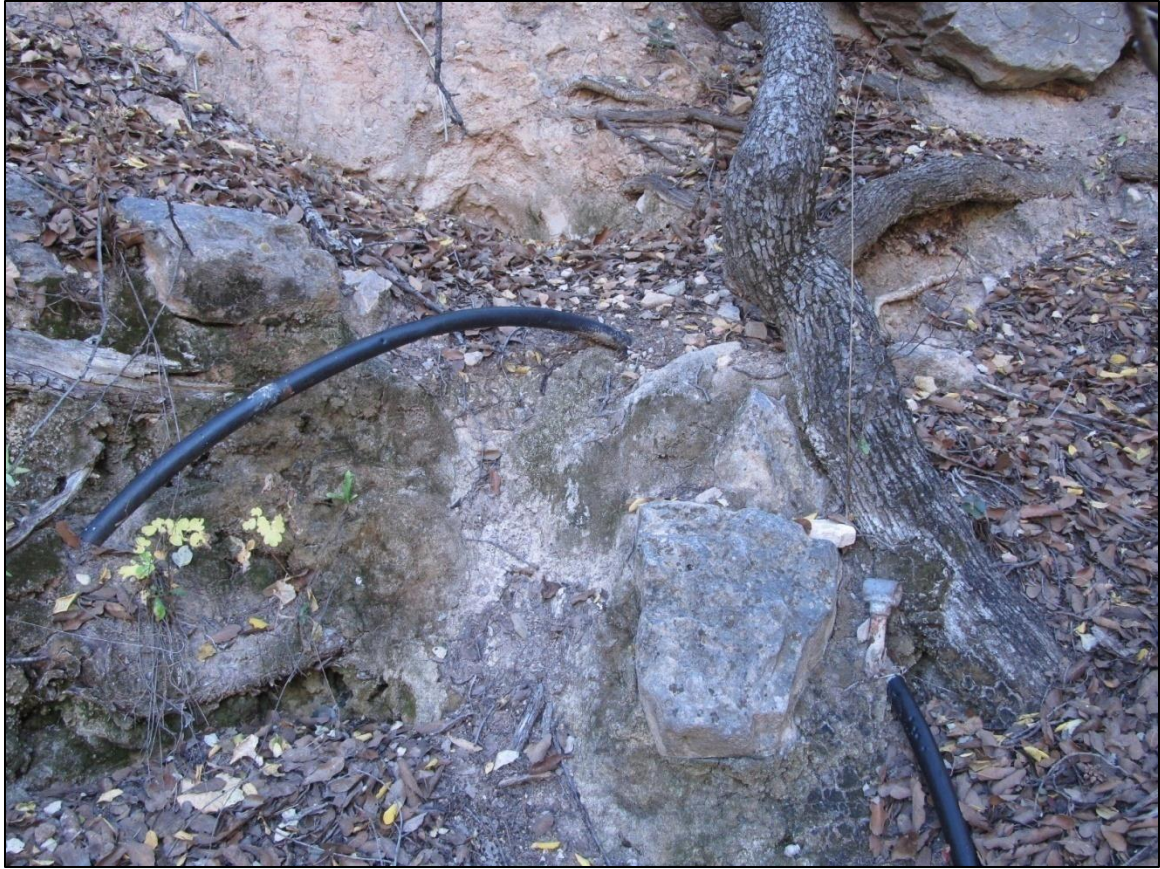
**Fig 21.1 Coyote Spring.**

**Physical Description:** Coyote Spring is an exposure spring piped directly from the steep rock face. The distance to the nearest spring is 1202 meters.

**Survey Notes:** At the time of visit the flow at the site was completely regulated. There was low flow coming from a pipe and leaking onto the ground and a former cattle drinker that was not currently in use. The wetted soil area was about 1 m squared.

Overall, the site condition is poor with limited restoration potential and there is negligible risk.

**Management Recommendations:** This spring had a low but detectable flow. 100% of the spring water was piped from a rock wall. The pipe outflows to the canyon bottom forming a small pool (less than 1 meter-squared). There is an old cattle drinker on site that is no longer filled by the spring.

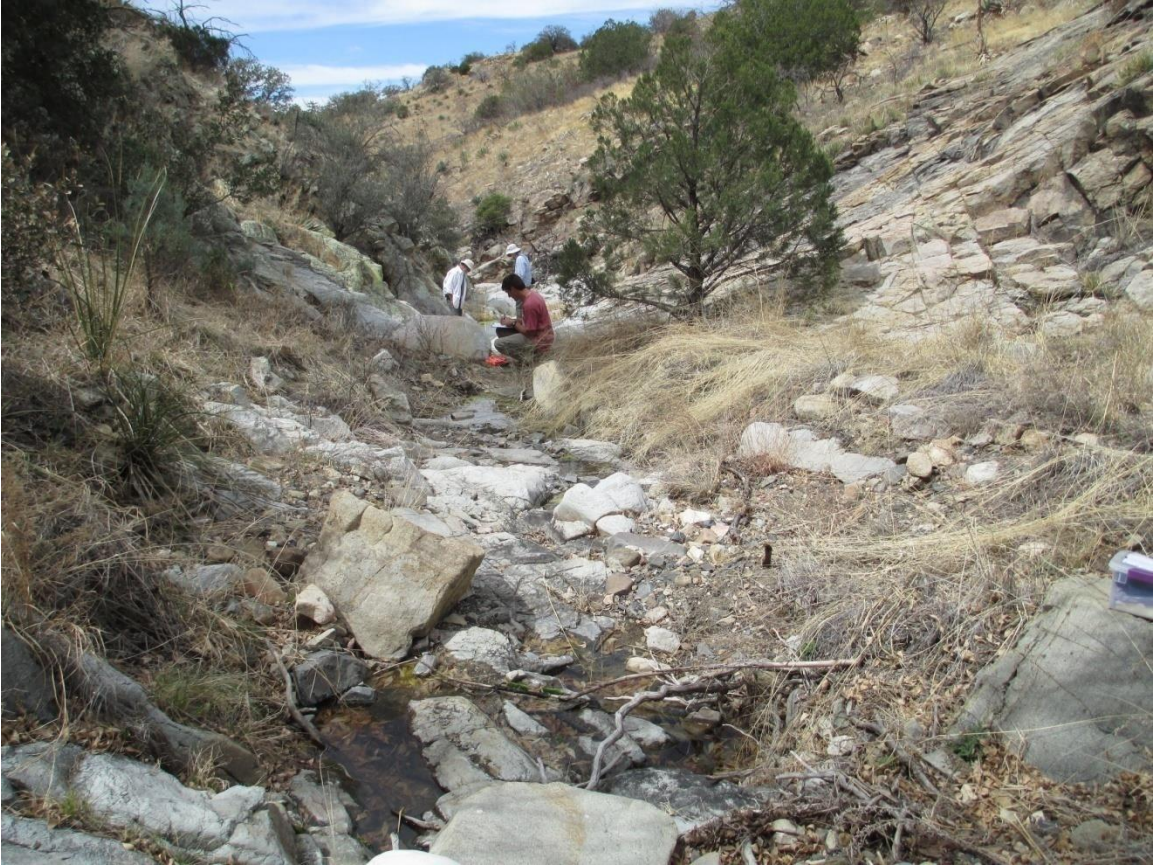
**Fig 22.1 Death Trap Spring.**

**Physical Description:** Death Trap Spring is located in a narrow mountainous canyon in an oak woodland with pronounced bedrock exposure creating tinaja structures. The microhabitat associated with the spring covers 105 m<sup>2</sup>. The distance to the nearest spring is 874 meters.

Overall, the site condition is good with significant restoration potential and there is negligible risk.

**Management Recommendations:** According to Dennis Caldwell, this area should support mud turtles. Cows could obliterate what is left of sensitive plants, and old fencing is not working, so new fencing should be installed to protect neighboring springs.

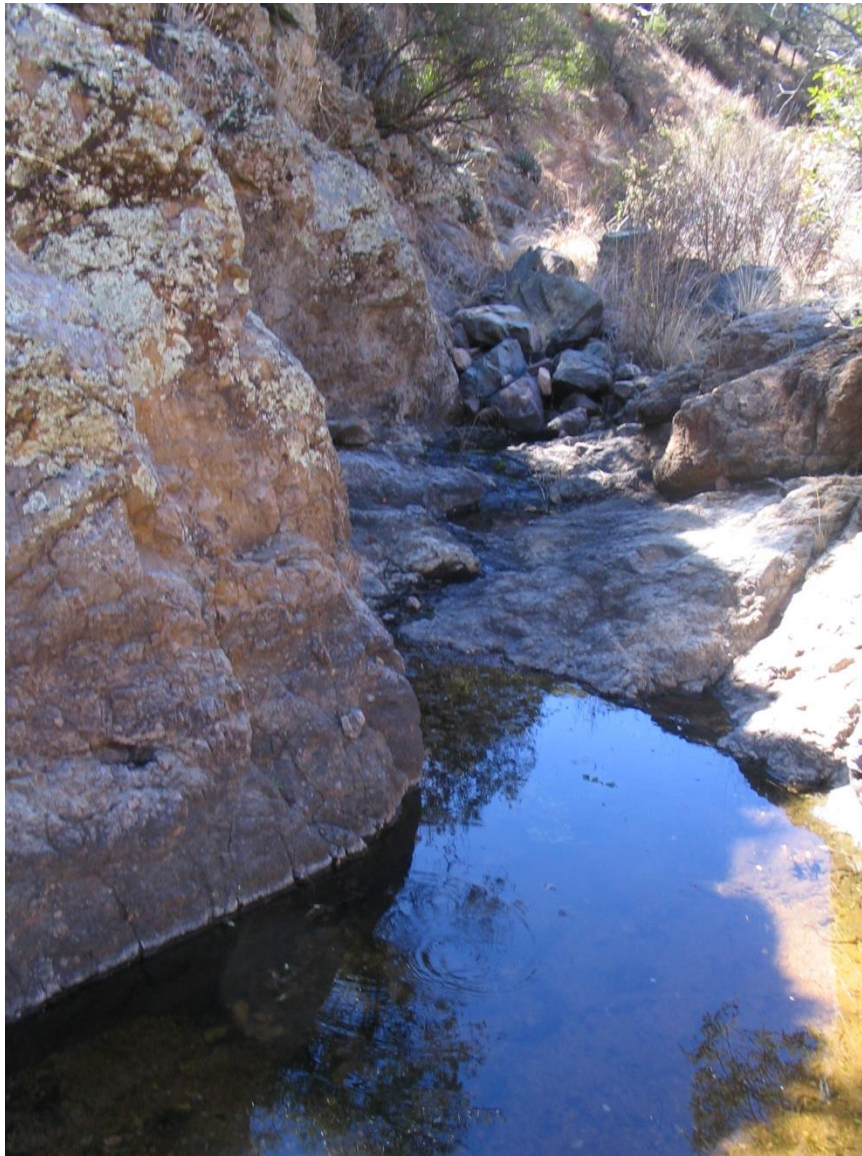
**Fig 23.1 Dripping Spring.**

**Physical Description:** Dripping Spring is a rheocrene intermittent spring. It is located in a bedrock channel with multiple pools, some moss and quatic plants, and is probably ephemeral. The microhabitat associated with the spring covers 383 m<sup>2</sup>. Geomorphic diversity is 0.19, based on the Shannon-Weiner diversity index. The distance to the nearest spring is 1325 meters.

**Survey Notes:** There was some evidence of grazing and some garbage from migrants. Overall the site was in good condition.

Overall, the site condition is good with significant restoration potential and there is negligible risk.

**Management Recommendations:** There was a small amount of migrant trash. There was a very large tank that would be extremely hard to remove. Presence of moss and aquatic insects indicate the spring is consistently wet.

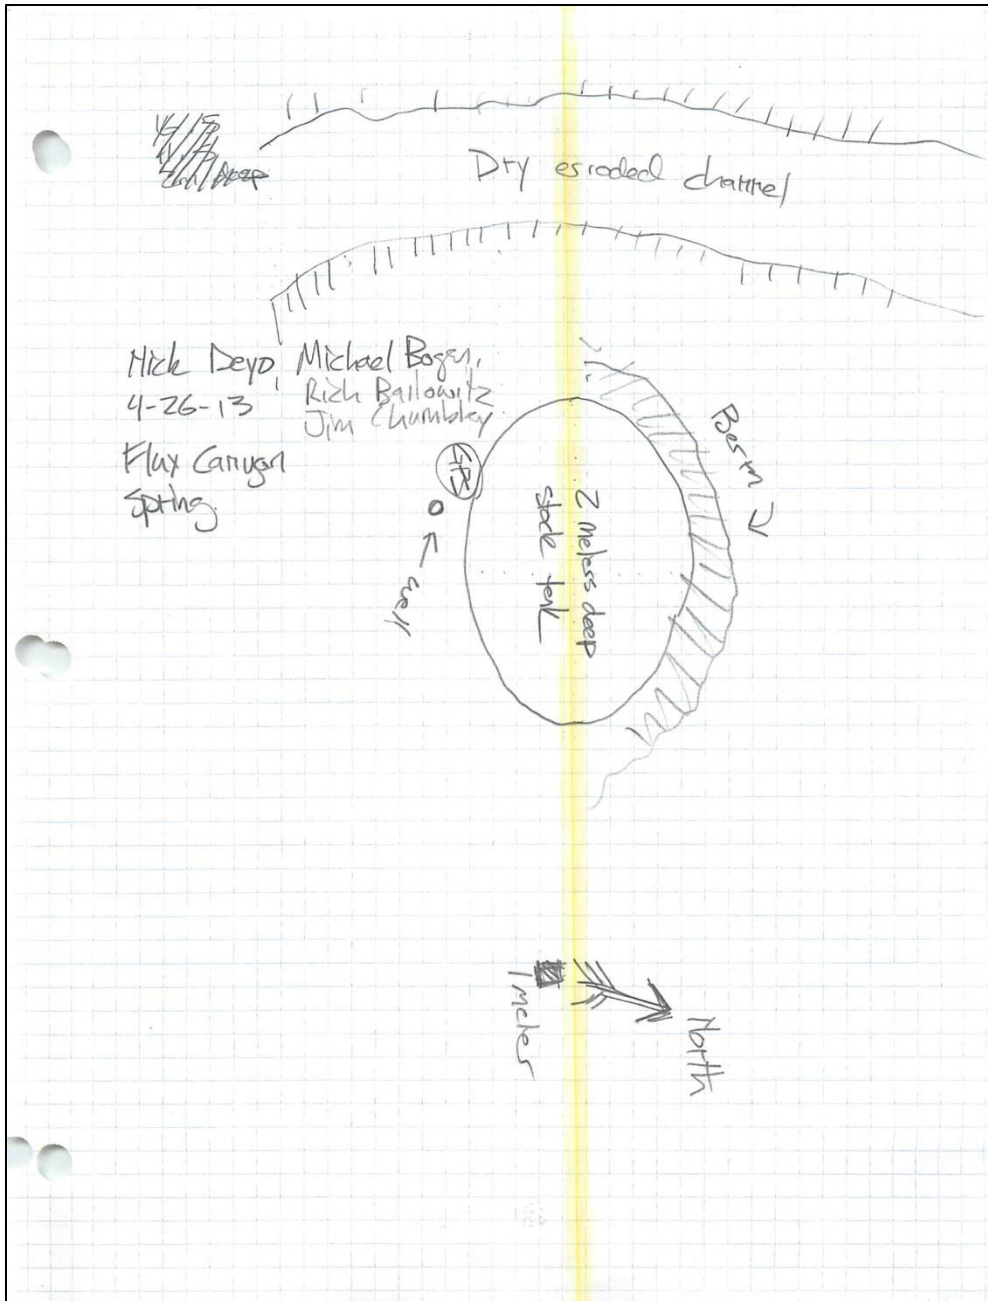
Fig 25.2 Flux Canyon Sketchmap.

Overall, the site condition is very poor with very limited restoration potential and there is high risk.

**Management Recommendations:** A smaller solar setup would be able to supply water to the site. The site has been obliterated and consists of a dry stock pond and a well.

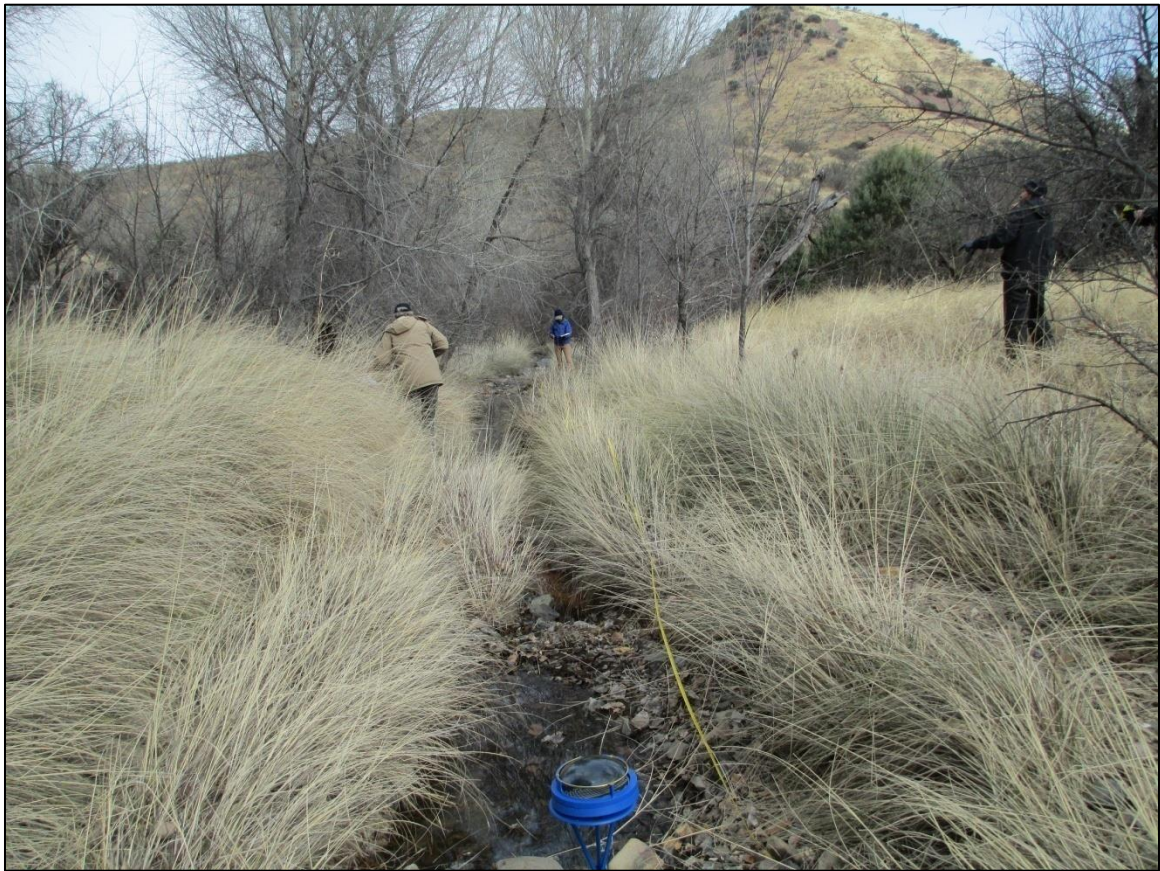
**Fig 26.1 Gate Spring.**

**Physical Description:** Gate Spring is a rheocrene spring, located in an open stream channel, upstream from a petroglyph site in a mixed oak woodland. The spring is within a cattle enclosure that was established in 1994. The microhabitat associated with the spring covers 280 m<sup>2</sup>.

**Survey Notes:** The site is in very good condition with the spring emergence point at the time of this survey located upstream of where it was previously mapped. At time of survey the emergence point was a ponded area with free flowing water below.

**Management Recommendations:** This site is well protected and likely a good reference site for Rheocrene spring. There is a possibility of the water table rising since the spring was originally mapped because we located the origin further upstream. Maintain enclosure as spring site appears very healthy and is showing signs of recovery. There is a lot of mining pressures in this area that may negatively affect spring health.

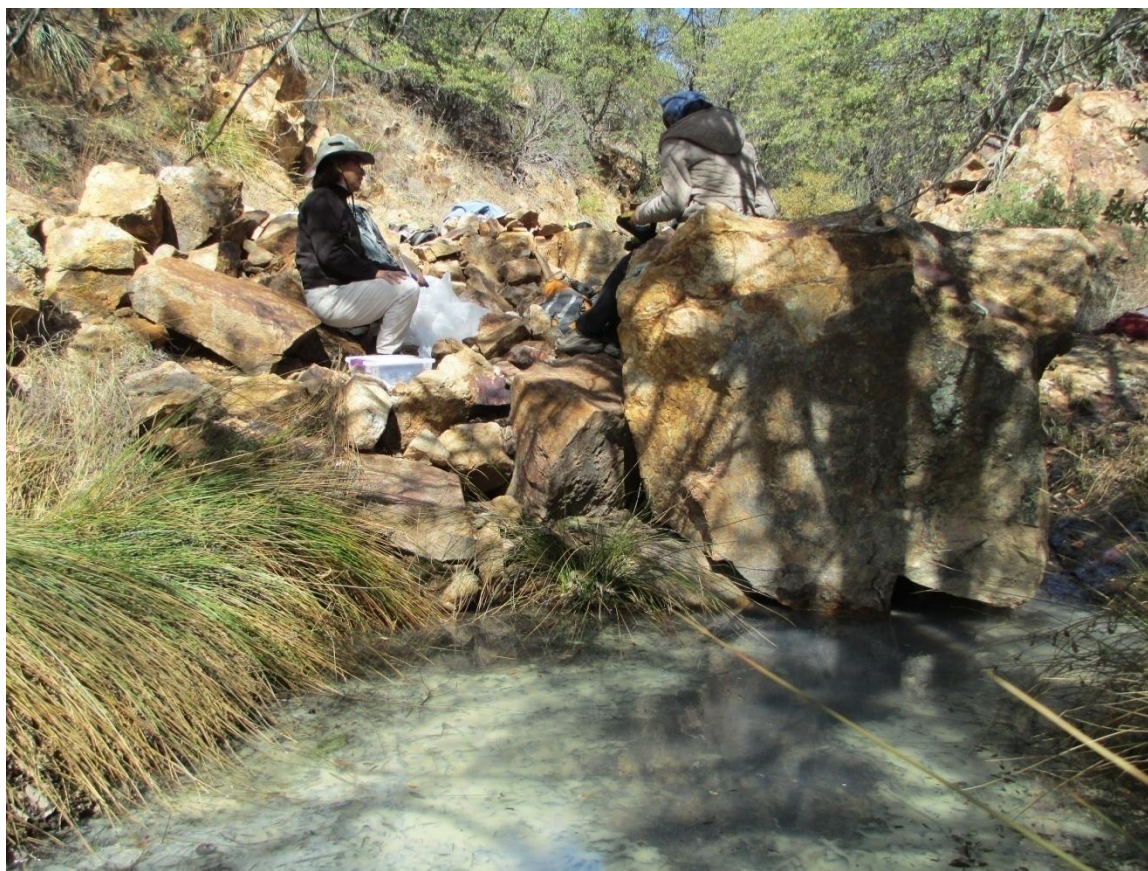
**Fig 28.1 Happy Jack Unnamed.**

**Physical Description:** Happy Jack Unnamed is a rheocrene intermittent spring. This spring emerges as two main seeps from a bedrock channel forming two large pools (2m in diameter), a spring channel, and stands of *juncus* spp. There are historic mine sites located above the spring in the drainage. The habitat surrounding the spring is oak woodland and desert grassland. There is an old roadbed that is adjacent to the spring channel. The aquatic fauna consists mostly of stopover

**Management Recommendations:** The spring is located in a superfund site and may have water quality issues. It remains an important resource for wildlife, however, it should be addressed in any clean-up efforts. Although site has very poor water quality, mining contamination is visually pervasive and this would be a very difficult site to remediate.

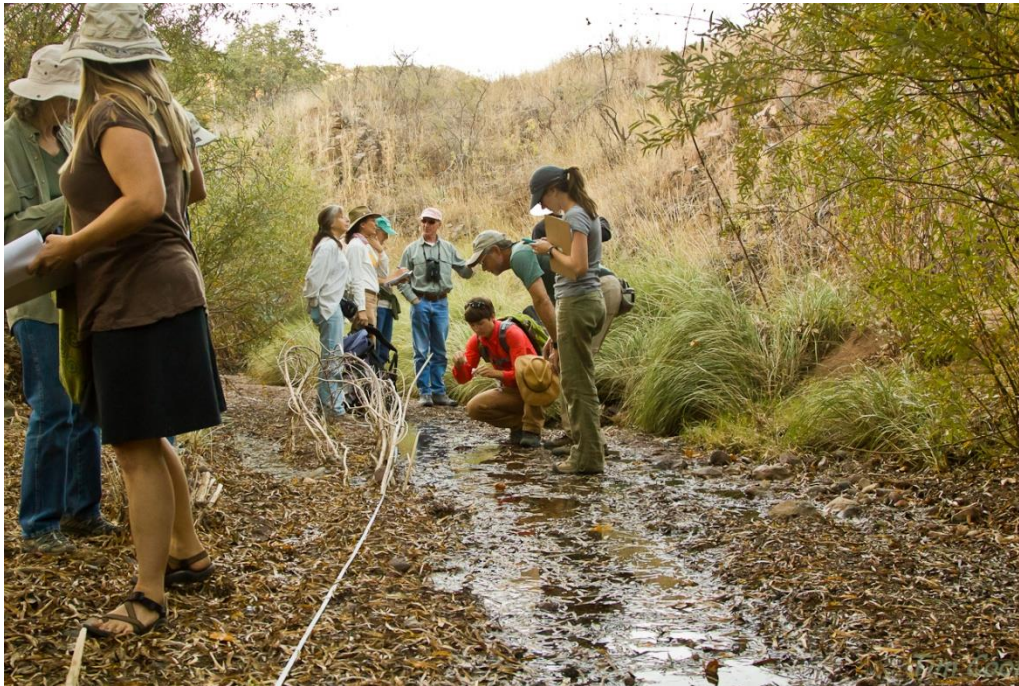
**Fig 29.1 Harshaw Creek unnamed.**

**Physical Description:** Harshaw Creek unnamed is a rheocrene that emerges in the Harshaw Creek channel along Harshaw Creek Road, within a somewhat narrow and steep canyon. There are scattered residential properties all along this road next to the creek channel. The microhabitat associated with the spring covers 275 m<sup>2</sup>. Geomorphic diversity is 0.0, based on the Shannon-Weiner diversity index.
