# Appendix B: Spring Inventory Reports

## 1. Alamo Spring Survey Summary Report, Site ID 12981

Submitted December 23, 2013 by Sky Island Alliance

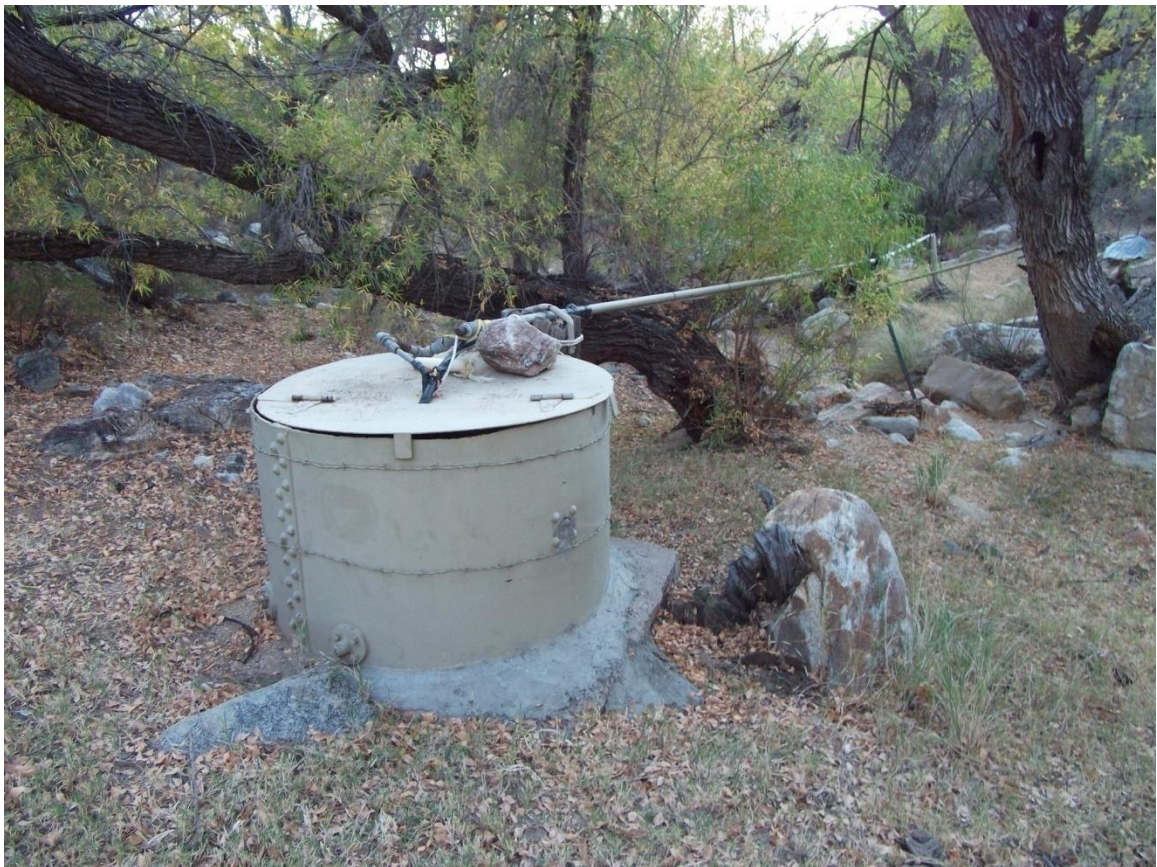
**Fig 30.1 Hidden Spring.**

**Physical Description:** Hidden Spring is a rheocrene/anthropogenic spring. This site is in a canyon surrounded by foothills thornscrub. The spring is on an allotment and has been completely developed. There is a well with an electric pump at what was probably once the spring source. The water is piped to storage tanks which feed several cattle drinkers. There is a small shack next to the spring/well. The microhabitat associated with the spring covers 375 m<sup>2</sup>.

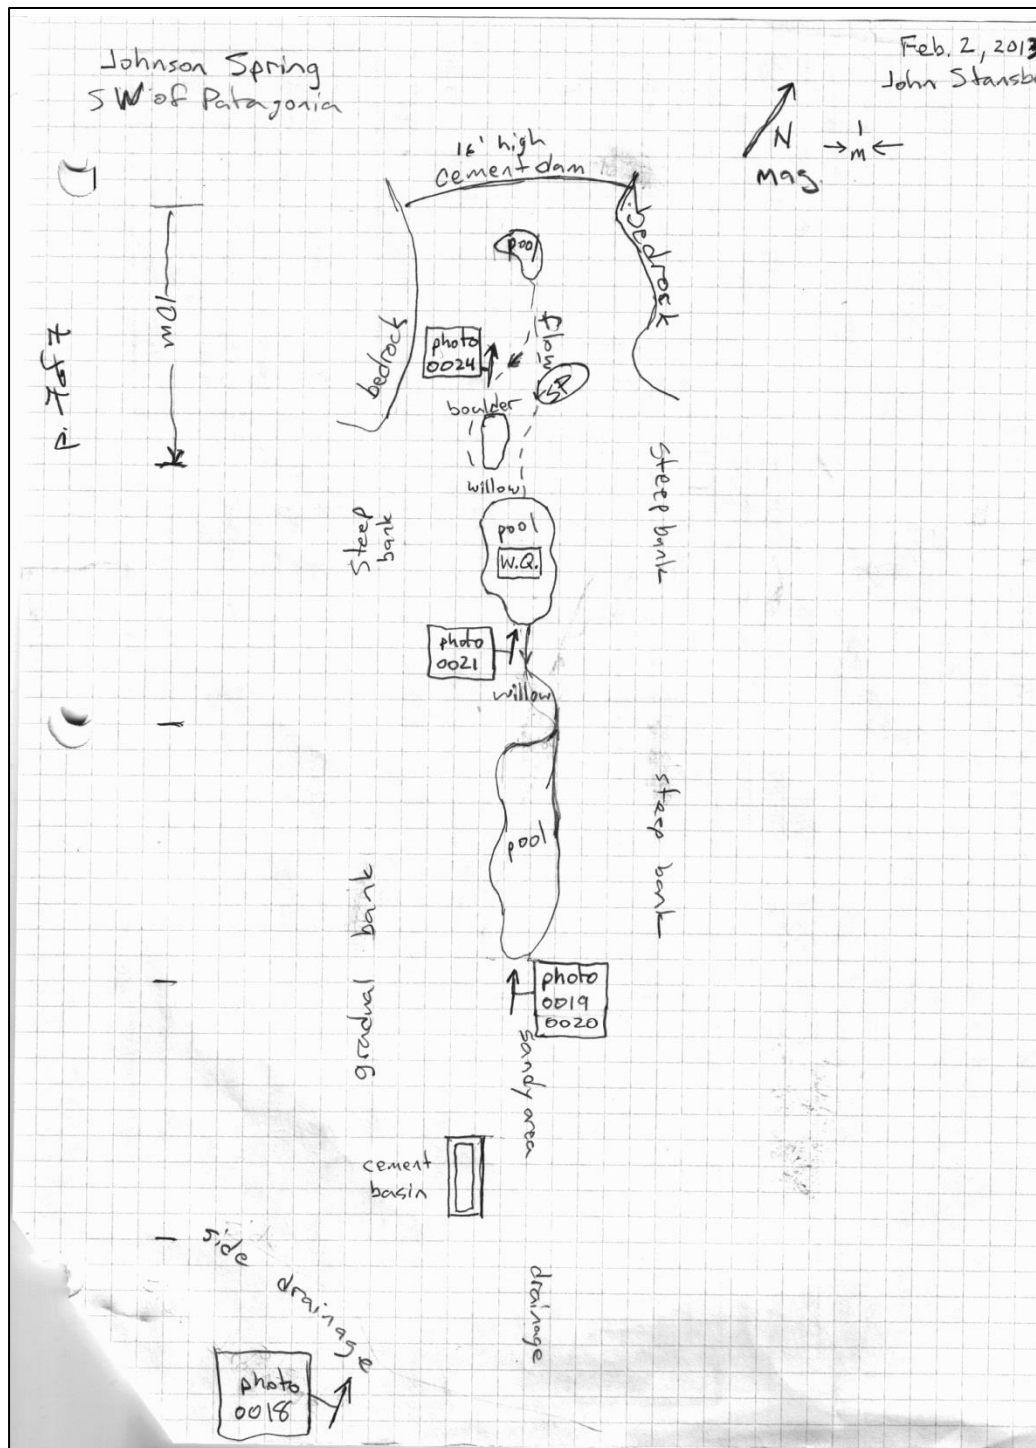
Fig 31.2 Johnson Spring Sketchmap.

**Management Recommendations:** This spring is highly developed with an old dam dominating the morphology of the spring. Removal of the dam would be very difficult due to the extensive amount of sediment upstream. However, the spring has large pools that support wetland species, making it an important management concern.

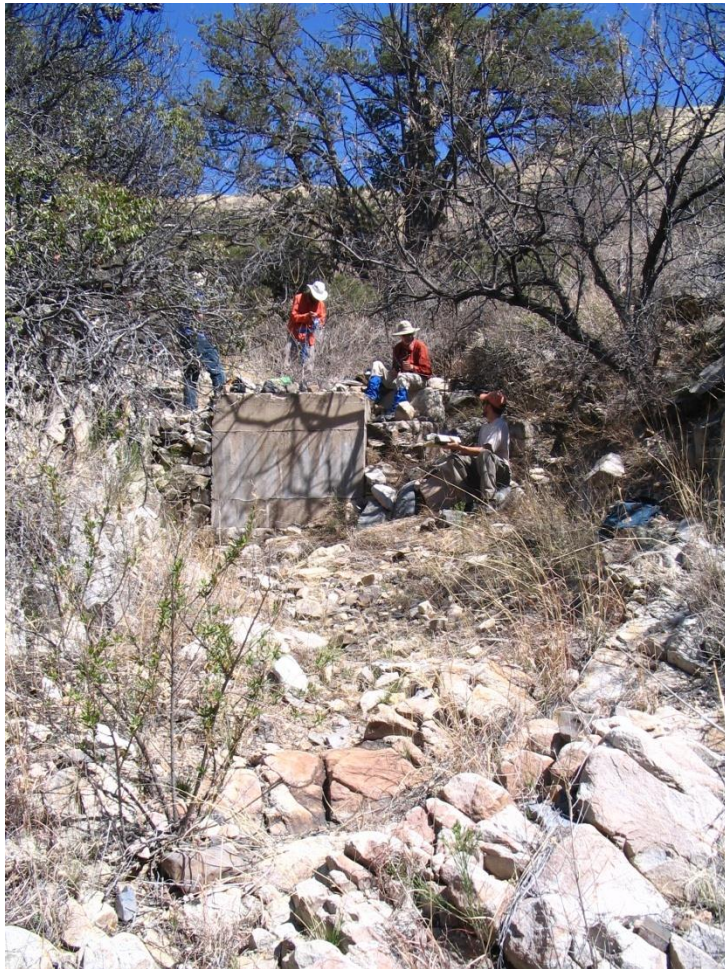
**Fig 32.1 Juniper Spring.**

**Physical Description:** Juniper Spring is a rheocrene site that has a cement spring box, and is located in a steep bedrock and cobble channel. There are old pipes and a cement drinker associated with the spring. The microhabitat associated with the

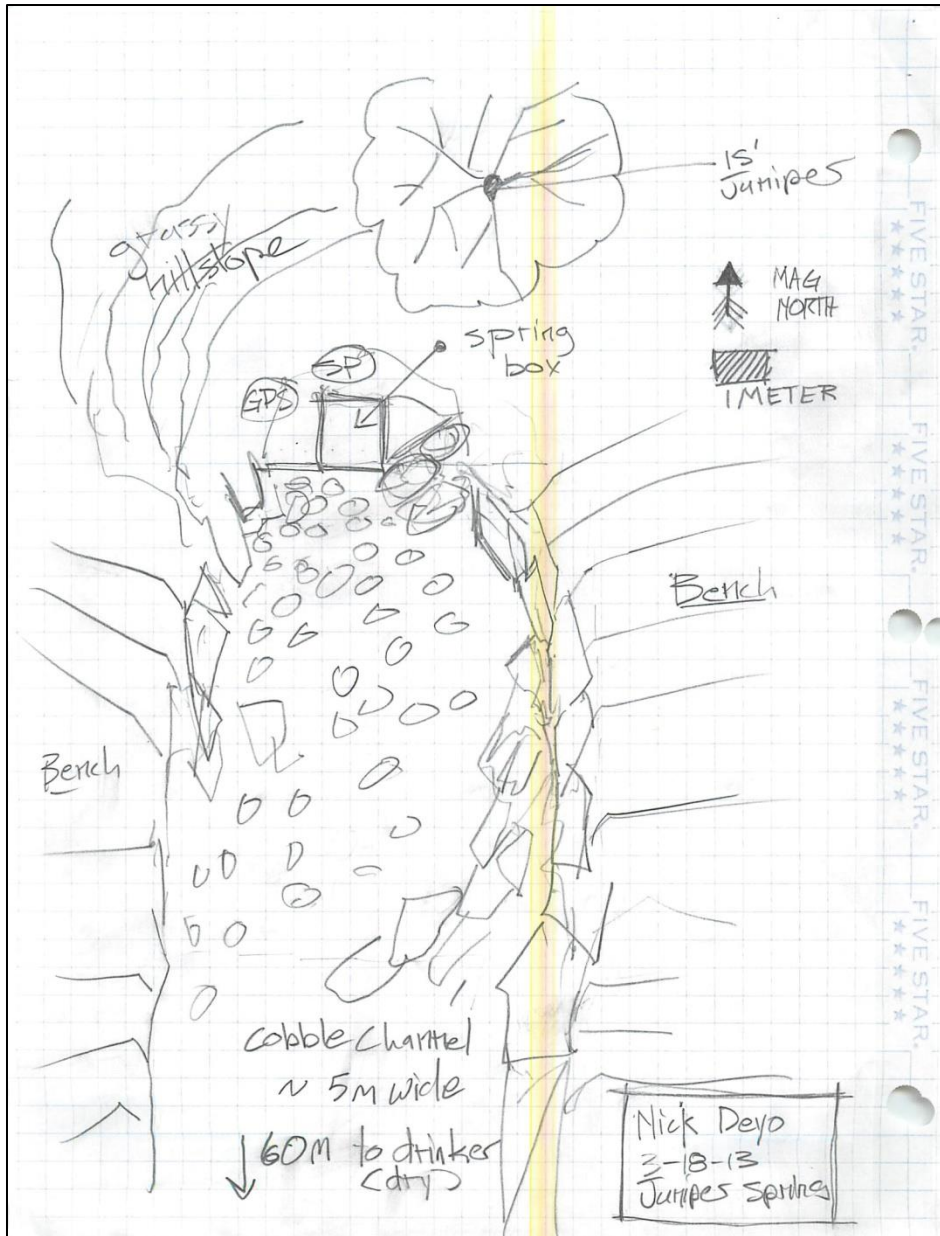
**Fig 32.2 Juniper Spring Sketchmap.**

**Management Recommendations:** There was no water at this spring and it has been highly altered by a spring box. It is a low restoration priority.

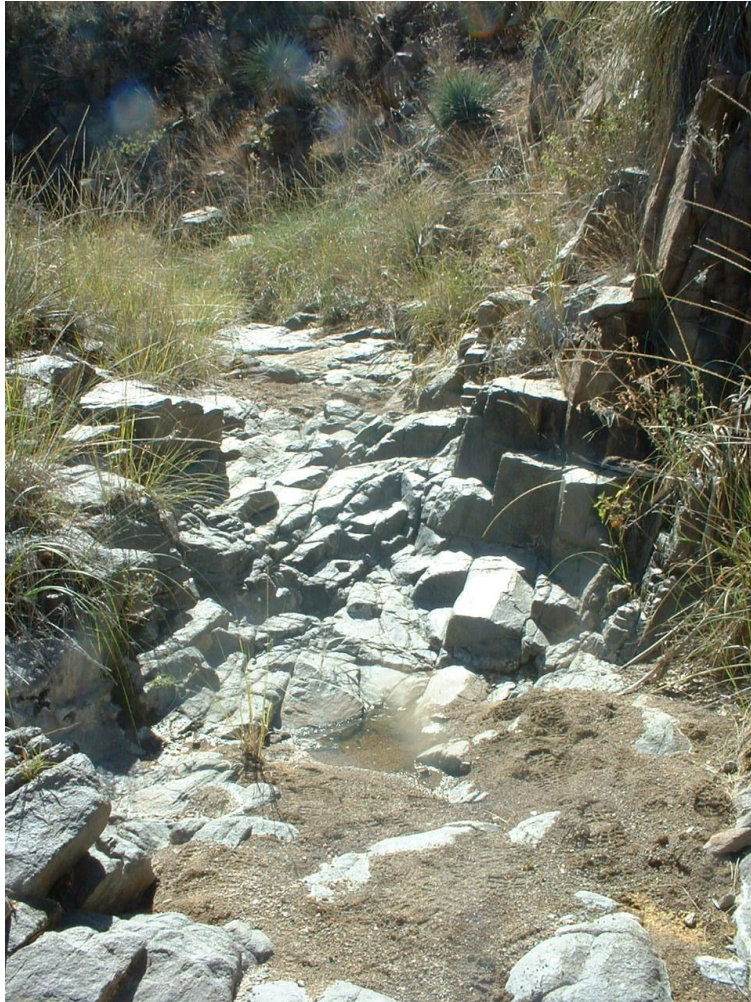
**Fig 33.1 Kennedy Spring.**

**Physical Description:** Kennedy Spring is a rheocrene that emerges from numerous locations in a primarily bedrock channel. The canyon is very steep and supports desert grassland and oak woodland habitat. Water seeps from fractures in the bedrock and becomes exposed in the alluvium as well. Small pools and patches of deer grass provide some riparian and wetland habitat. The microhabitat associated with the spring covers 70 m<sup>2</sup>.

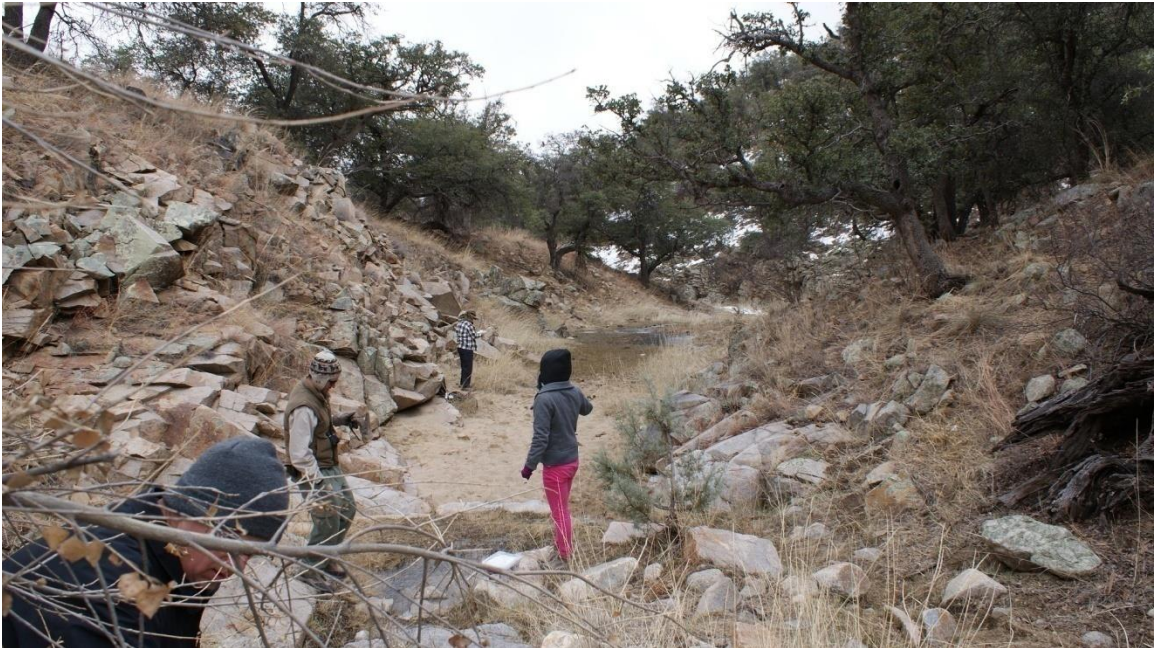
Fig 35.1 Line Boy Spring.

**Physical Description:** Line Boy Spring is a rheocrene spring. The likely origin of the spring is near a young cottonwood that has been undercut. The spring discharges from a narrow drainage surrounded by Oak woodland habitat. It was within the vicinity of Line Boy Mine and consisted of a channel, very little flow, and two pools less than 1 m. in diameter. The microhabitat associated with the spring covers 936 m<sup>2</sup>. Geomorphic diversity is 0.0, based on the Shannon-Weiner diversity index.

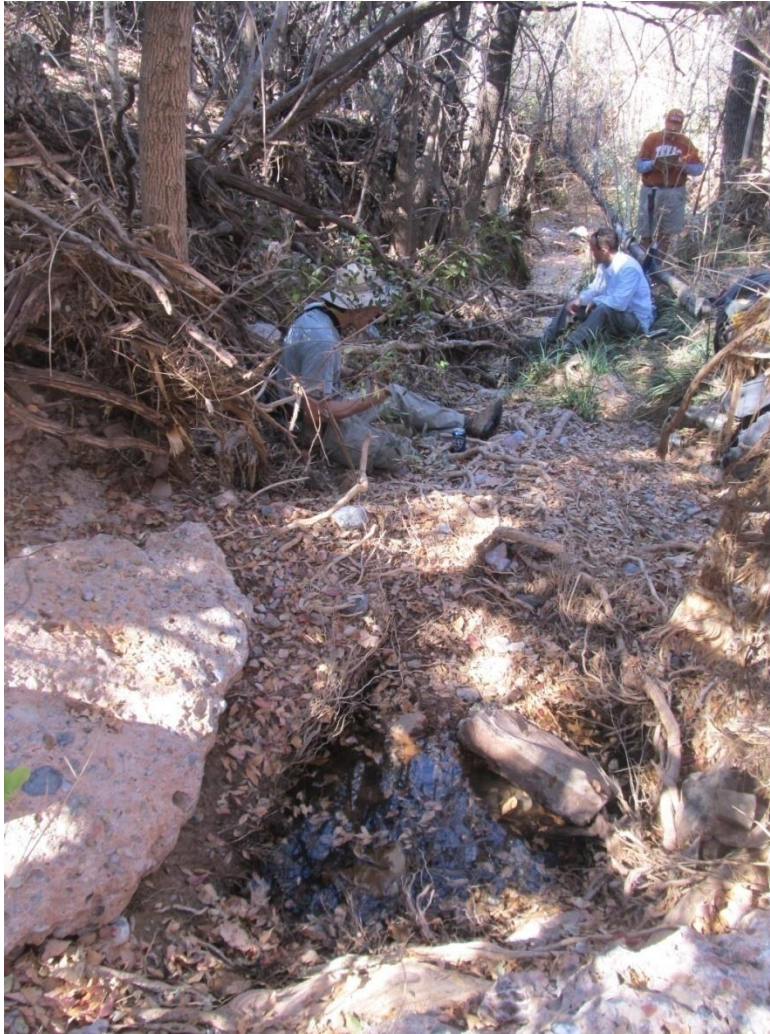
**Fig 36.1 Little Nogales Spring.**

**Physical Description:** Little Nogales Spring is a rheocrene spring that emerges from a channel in a conglomerate rock formation in an otherwise limestone area. It is surrounded by thick riparian shrubs and trees and has a lot of leaf litter in the spring pools and spring channel. It had water at the time of the survey and consists of both pool and channel habitats. The end of the spring flow was recorded further down the channel at 12N 0549573 3528045. The microhabitat associated with the spring covers 100 m<sup>2</sup>.

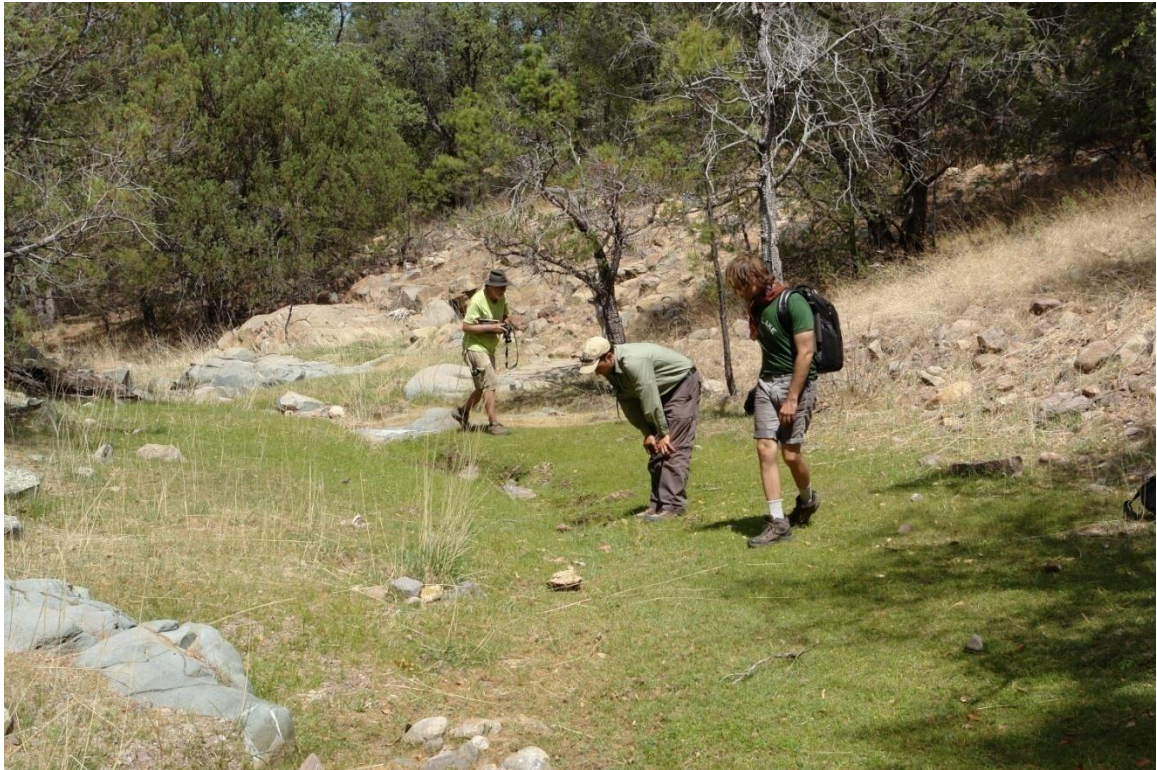
**Fig 38.1 Mud Spring.**

**Physical Description:** Mud Spring is a rheocrene spring located in a mountain canyon in Oak woodland habitat within the Miller Peak Wilderness. It is in close proximity to a FS trail. The microhabitat associated with the spring covers 146 m<sup>2</sup>.

**Survey Notes:** At the time of survey there was no water at the spring but there was fair sized patch of moist soil and the area looked recently wet. There was some cow signs around the spring and a small campsite that appears to get regular human use about 75 meters upstream.

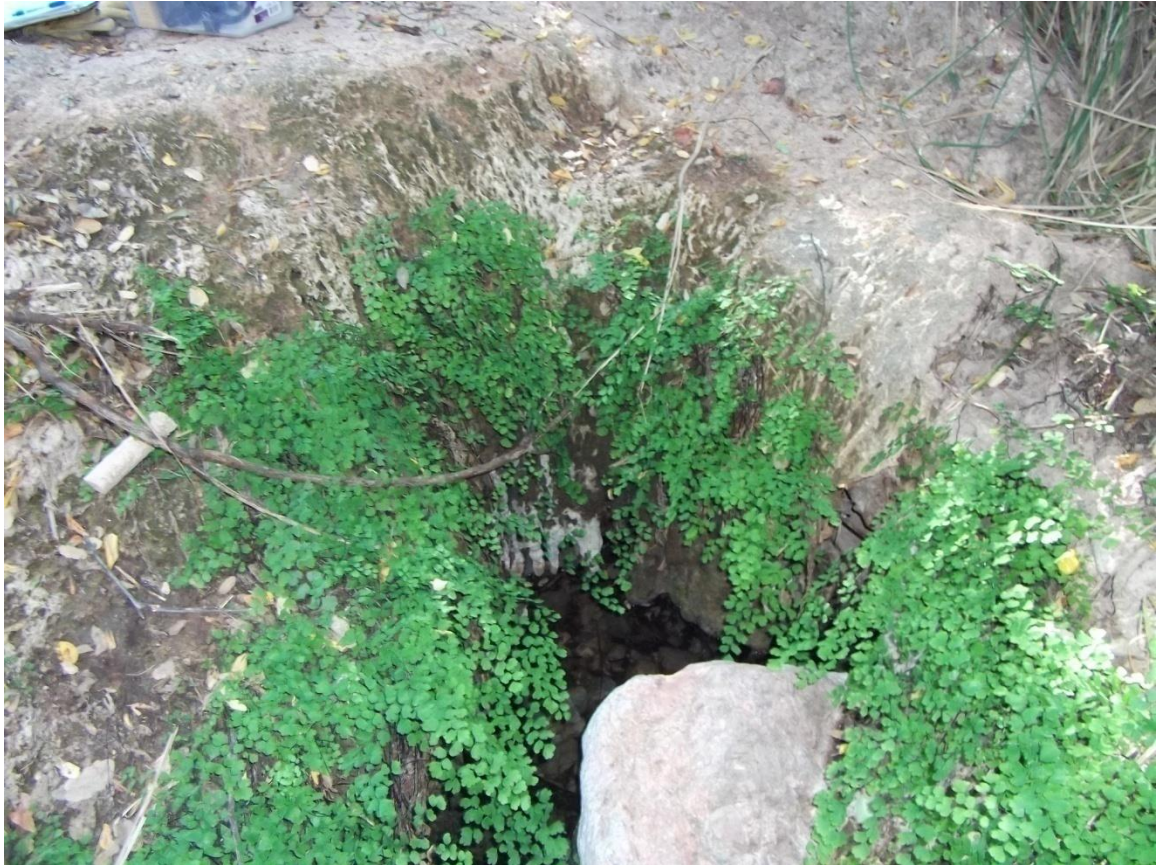
**Fig 39.1** Nogales Spring.

**Physical Description:** Nogales Spring is a mound-form/rheocrene perennial spring. The discharge is from a travertine mound which flows into a channel. The microhabitat associated with the spring covers 5,000 m<sup>2</sup>.

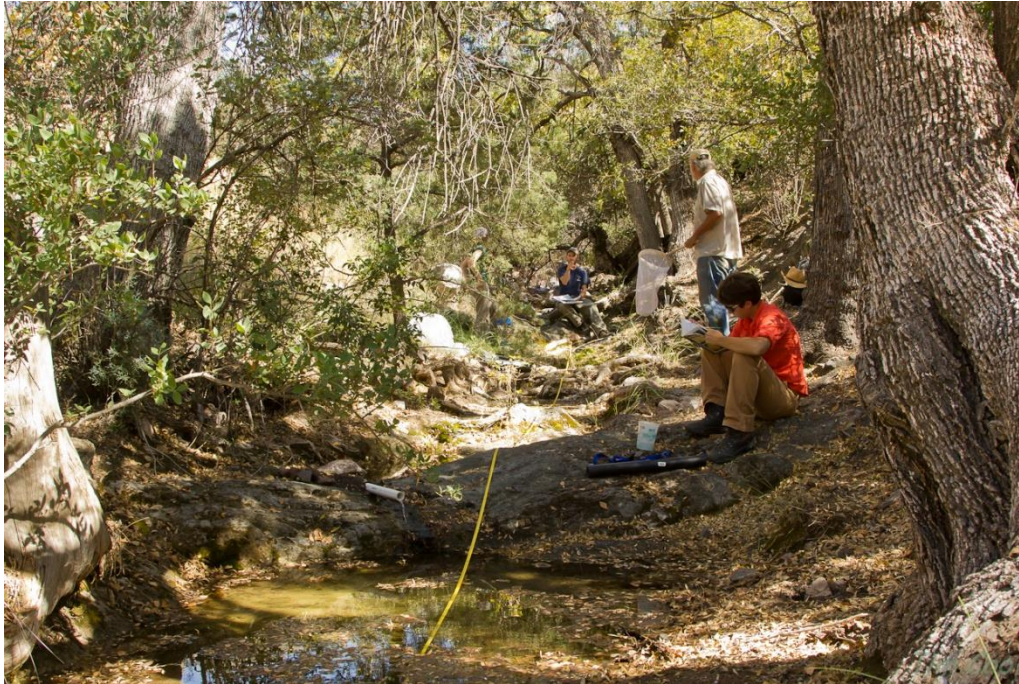
**Fig 40.1 Oak Grove unnamed south.**

**Physical Description:** Oak Grove unnamed south is a rheocrene perennial spring. The spring is located in a west-trending flow in a steeply-sided grassy drainage. Two springs were close within the same drainage but in different drainage branches. The microhabitat associated with the spring covers 288 m<sup>2</sup>.

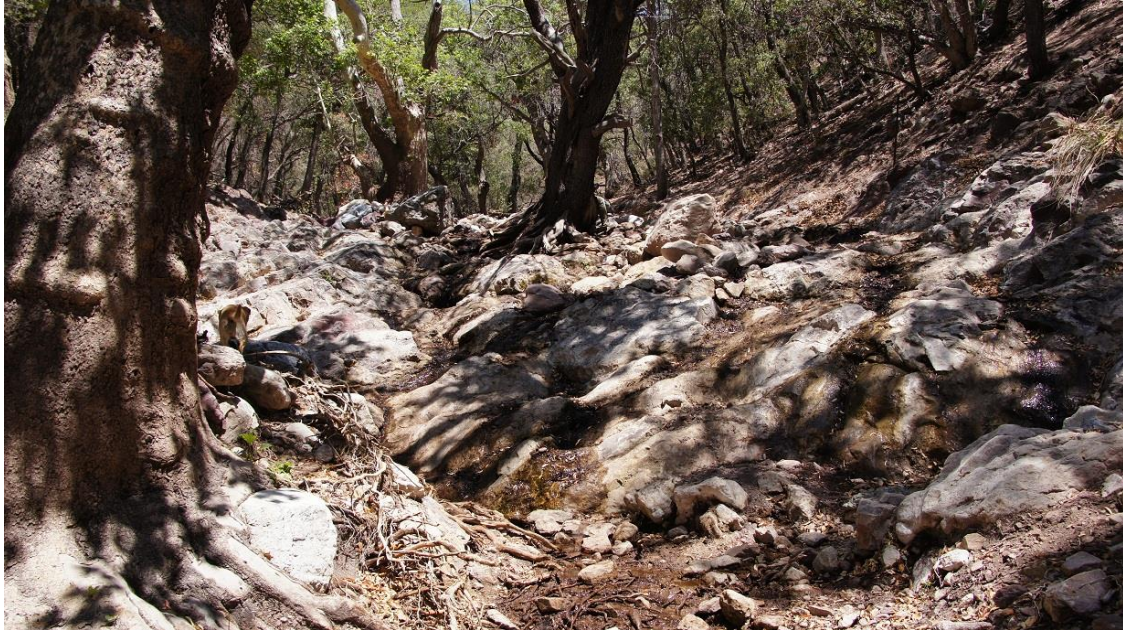
**Fig 41.1 Oak Spring.**

**Physical Description:** Oak Spring is a rheocrene perennial spring. This site is in a steep, rocky canyon. The microhabitat associated with the spring covers 312 m<sup>2</sup>. Geomorphic diversity is 0.0, based on the Shannon-Weiner diversity index.

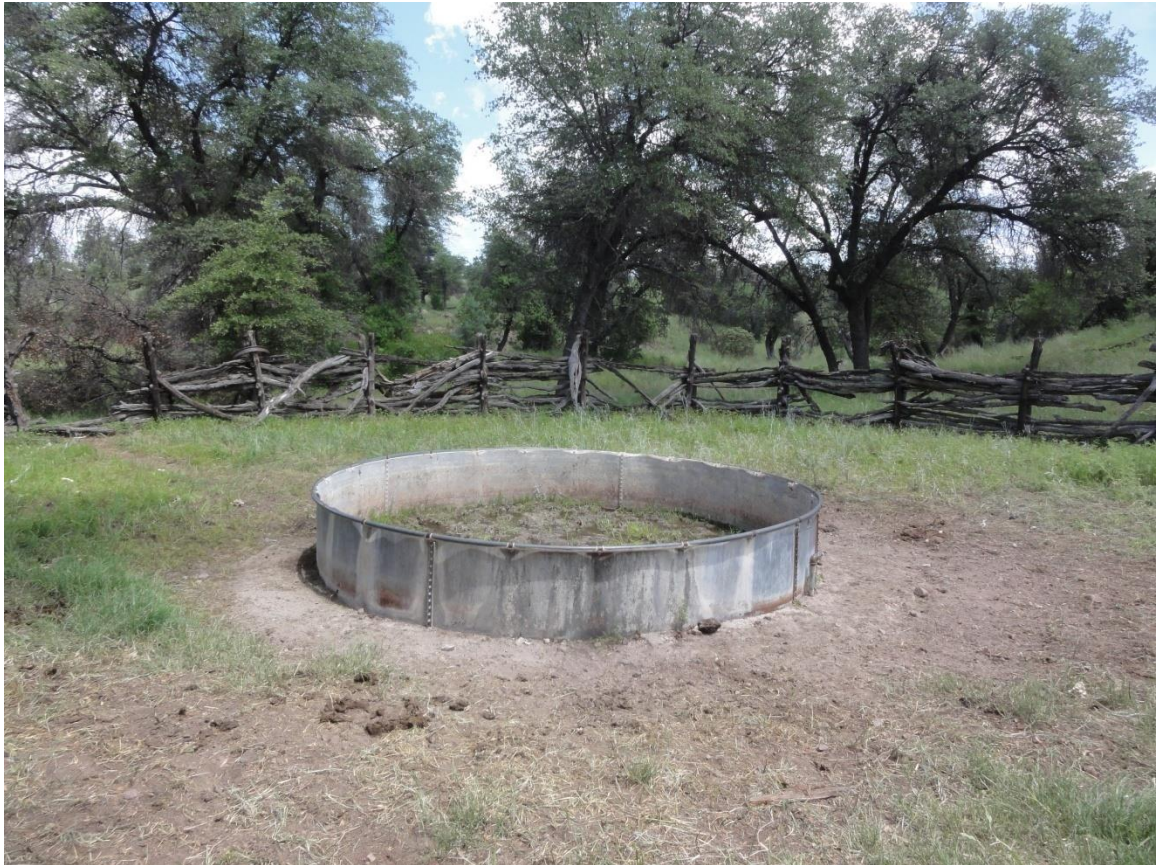
**Fig 42.1 Paloma Spring.**

**Physical Description:** Paloma Spring has been developed into a cattle drinker and the actual source point is unknown. Spring is located in an oak-woodland canyon. The microhabitat associated with the spring covers 504 m<sup>2</sup>. Geomorphic diversity is 0.0, based on the Shannon-Weiner diversity index.

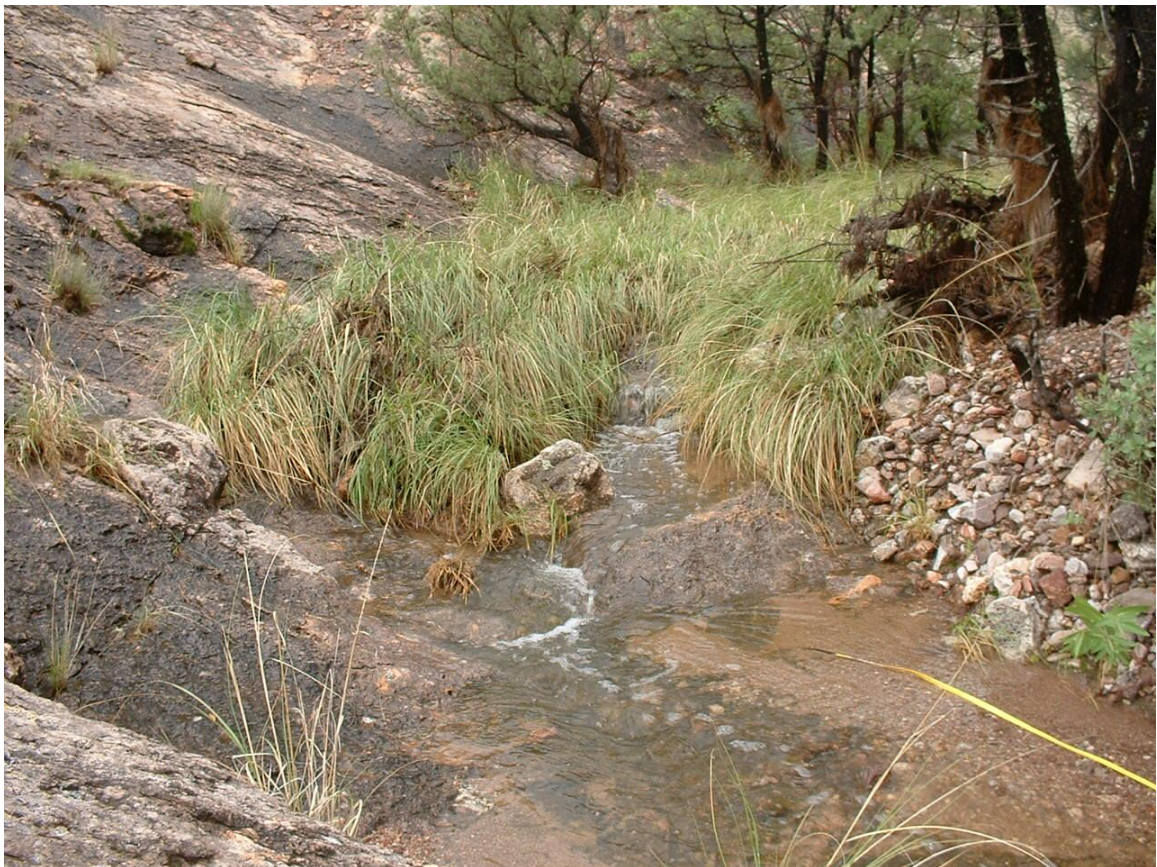
**Fig 43.1 Papago Spring.**

**Physical Description:** Papago Spring is a hillslope spring. The spring was at the bottom of Cienega Creek. Calcium carbonate may indicate a former spring and the biofilm indicated a hillslope source. Spring is in an oak woodland canyon. There is a concrete dam just below the source. The microhabitat associated with the spring covers 333 m<sup>2</sup>

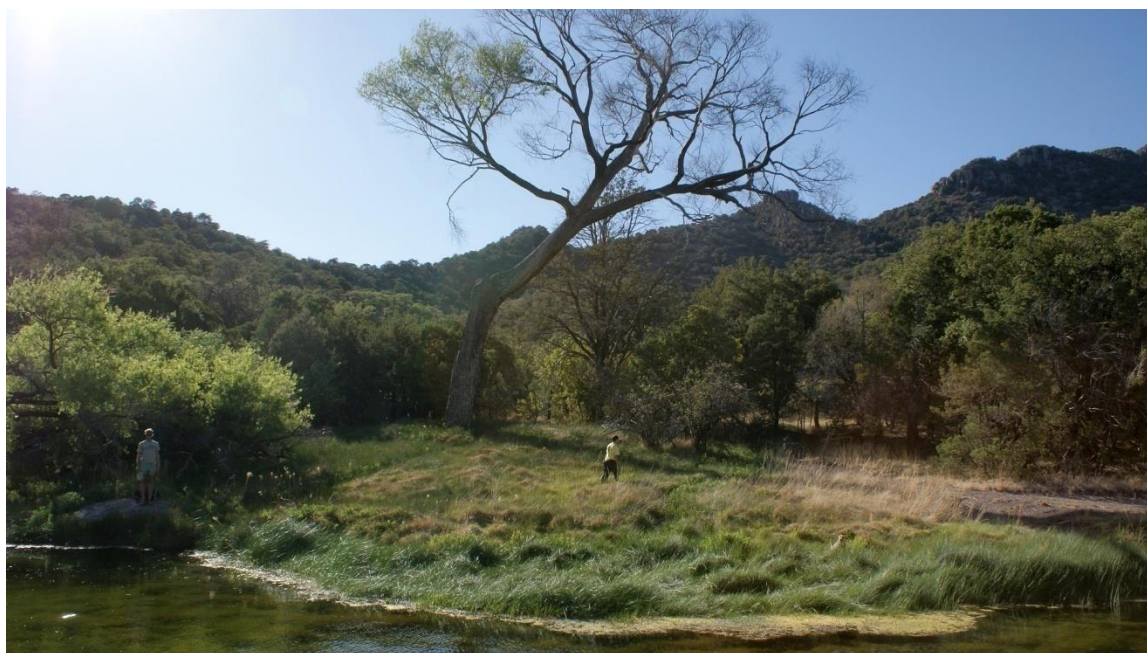
**Fig 44.1 Peterson Ranch Pond.**

**Physical Description:** Peterson Ranch Pond is a helocrene/anthropogenic perennial spring. This spring arises from an old springbox and flows into a narrow channel that feeds a 250 sq. meter wetland area. The spring outflow fills a large constructed pond (180 sq. meters) where Chiricahua leopard frogs have been introduced and are reproducing. This is an important area for Chiricahua leopard frog recovery efforts. The microhabitat associated with the spring covers 460 m<sup>2</sup>. Geomorphic diversity is 0.0, based on the Shannon-Weiner diversity index.

**Survey Notes:** Site is in good condition as there is a fence around it. The pond has had bullfrogs and bullrushes removed in the past and contained Chiricahua leopard

**Management Recommendations:** The pond associated with this spring has been important for Chiricahua leopard frog recovery efforts. It has been infested with invasive bullfrogs in the past and it is important that it continue to be monitored and managed to prevent recolonization by bullfrogs.

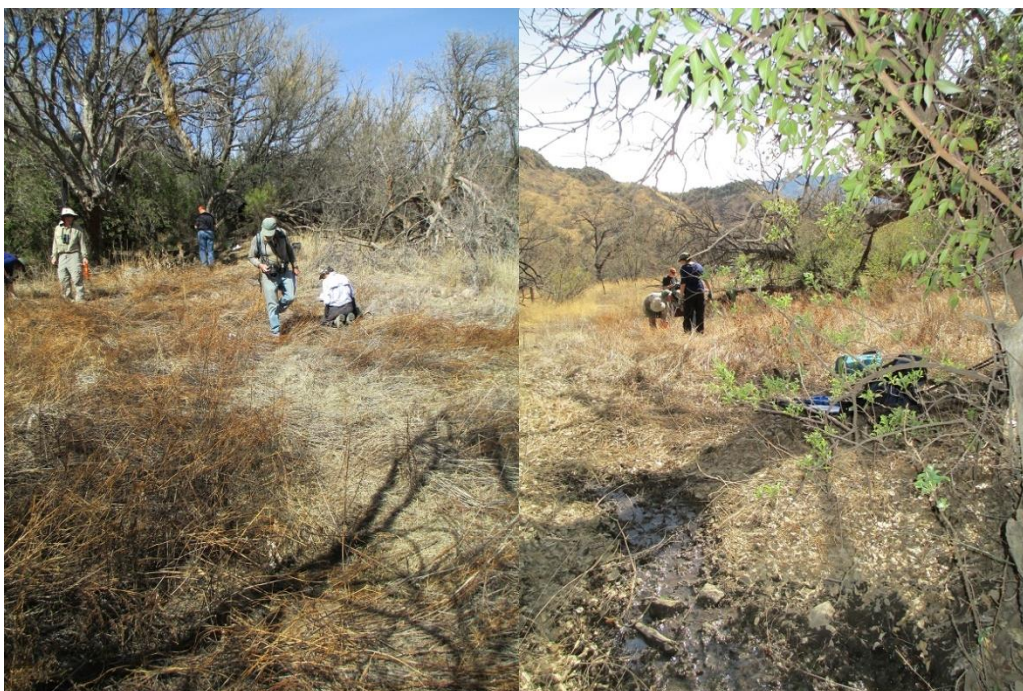
**Fig 46.1 Ranger Station Spring.**

**Physical Description:** Ranger Station Spring is a helocrene spring. This helocrene spring is located on a hillslope above a small steep drainage in primarily mesquite-scrub habitat with scattered oaks. The microhabitat associated with the spring covers 900 m<sup>2</sup>. Geomorphic diversity is 0.0, based on the Shannon-Weiner diversity index.

**Management Recommendations:** Site appears to have exclosure fencing which should be maintained. There is extensive old infrastructure for piping water from spring site to multiple large tanks downhill. There is some erosion and downcutting at the spring emergence that could be addressed and may be effecting spring flow.

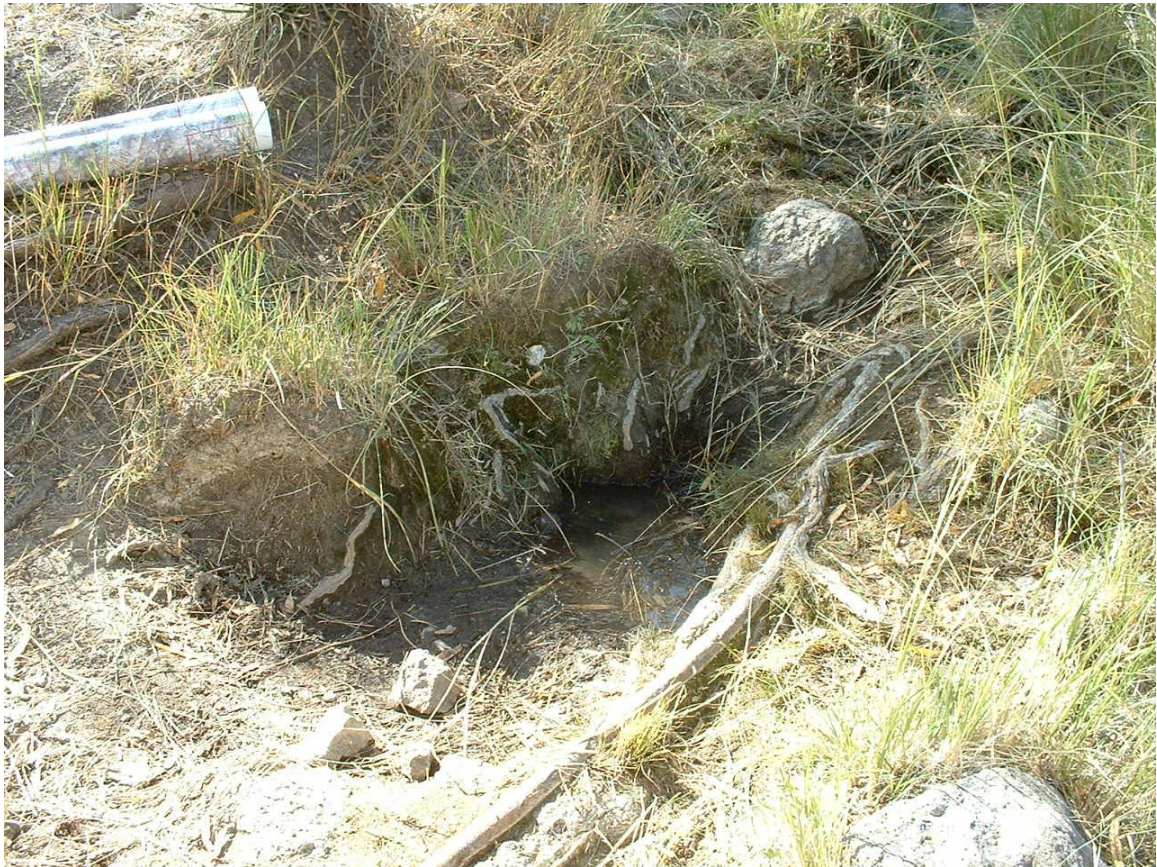
**Fig 47.1 Redrock South Spring Unnamed.**

**Physical Description:** Redrock South Spring Unnamed is a rheocrene spring. This spring emerges from a rocky outcrop in an upper watershed drainage. Little flow was noted and there are many dilapidated pipes on the site. The microhabitat associated with the spring covers 420 m<sup>2</sup>.

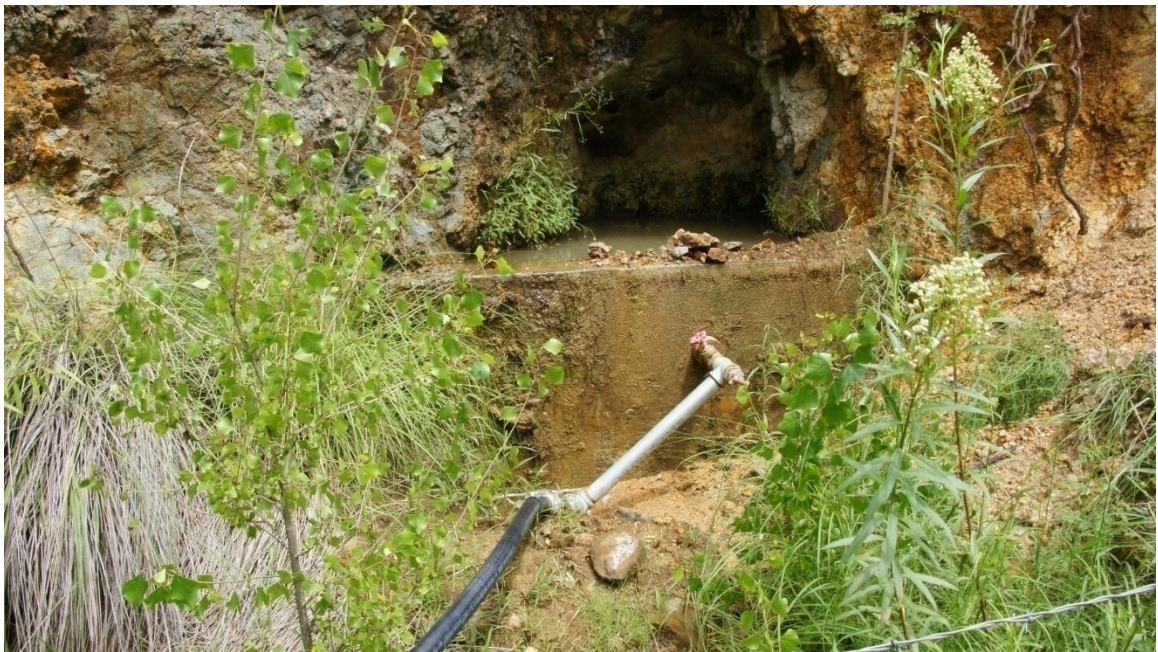
**Fig 48.1 Sansimon Mine unnamed.**

**Physical Description:** Sansimon Mine unnamed is a hanging garden spring. The spring issues from shallow cave in a rock outcropping and is highly developed. Nearly all of the water at the site is piped to two cement cattle drinkers. However, the area directly adjacent to the spring is fenced off from cattle. The microhabitat associated with the spring covers 45 m<sup>2</sup>.

**Management Recommendations:** This site is highly altered and no longer resembles its natural state. If the permittee is no longer using the cattle infrastructure at the site, restoration of the site to a more healthy ecological condition would be valuable. Water is making its way out of the spring box and creating a nice little moist run/wetland down to the creekbed. There is a lot of water available, but access to this USFS parcel is through a private ranch.

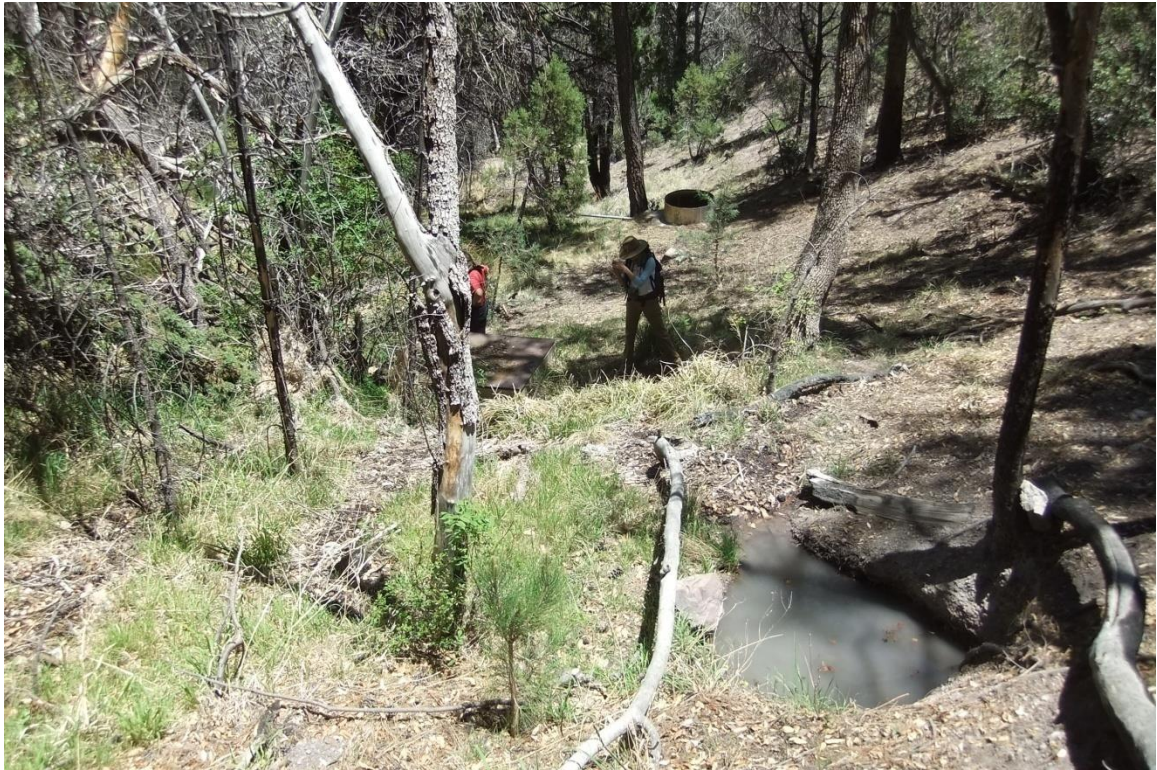
**Fig 49.1 Sawmill Spring.**

**Physical Description:** Sawmill Spring is a hillslope spring. The microhabitat associated with the spring covers 336 m<sup>2</sup>. Geomorphic diversity is 0.0, based on the Shannon-Weiner diversity index.

**Management Recommendations:** The spring is next to Sawmill Canyon trail and is at risk of trampling by people. The development at the spring may need maintenance to maintain flow. Fire in the area has reduced the canopy cover but that may allow other species to thrive. It will be important to monitor the spring for health and continue to protect the site from grazing.

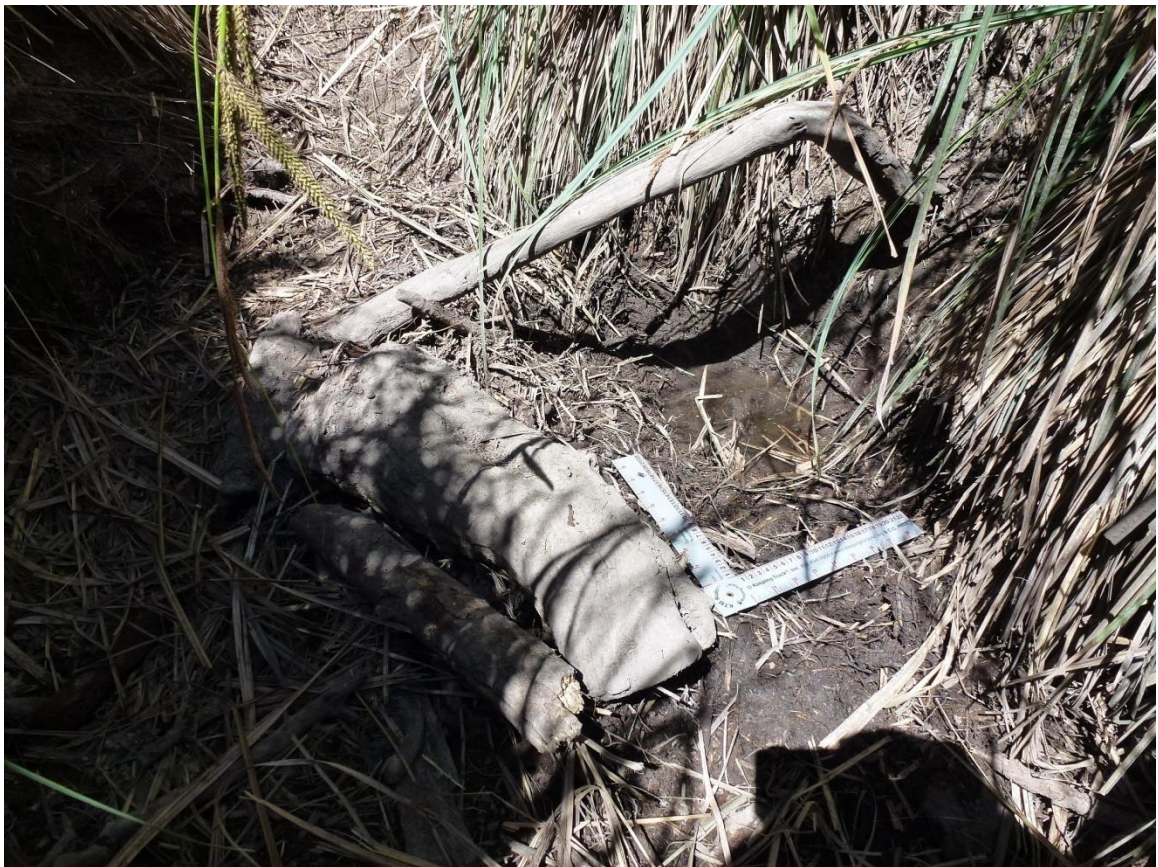
**Fig 50.1 Scholefield Spring.**

**Physical Description:** Scholefield Spring is a mound-form spring. This spring is located on a piedmont slope that is dissected by small gullies, which are incised into dark soils that look like old cienega soils (prehistoric). There is a plastic pipe that is cut and dry. A steel pipe emerges next to the plastic pipe which has dampness in it. There is also a steel barrel within the cienega which sticks up out of the ground several feet. At the downstream end of the site, outside of a fence there is an old cattle drinker with taverine deposits on it. There is evidence of old excavation at

**Water:** There was no measurable flow. Water quality was taken with a thermometer and by observation. The water in a small pool appeared slightly turbid, and was brownish with a strong odor of decay. The water quality appeared similar to a visit in 2006.

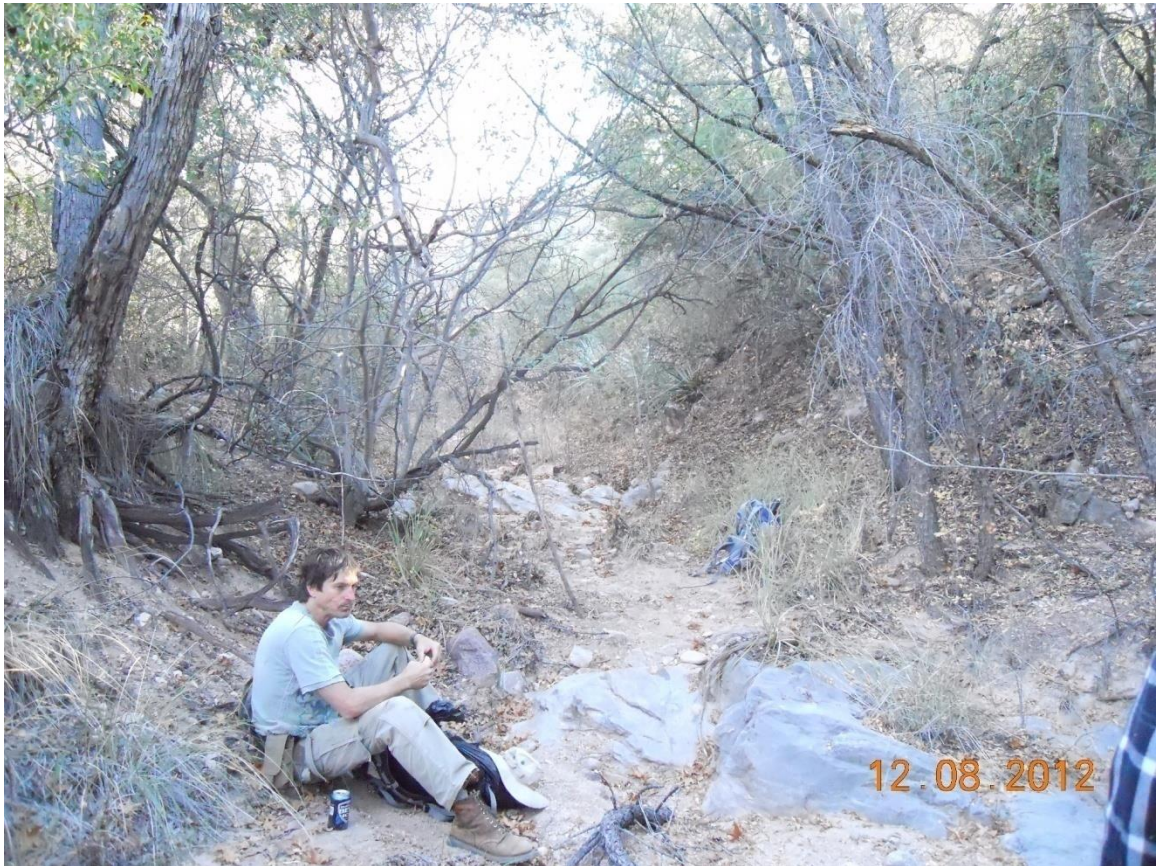
Fig 51.1 Silver Spring.

**Survey Notes:** There was no water at this site other than some moist ground. The channel was dominated with Sycamore and Ash.

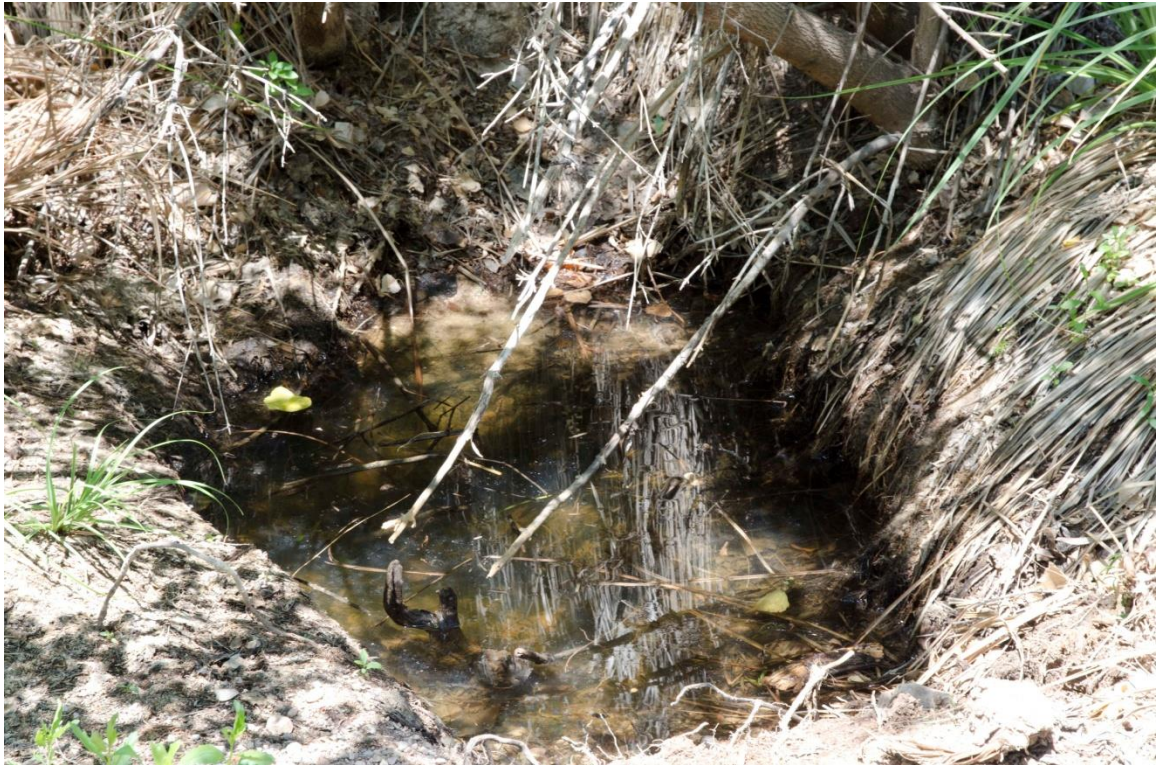
**Fig 52.1 Smitty Spring.**

**Physical Description:** Smitty Spring is a rheocrene spring. The spring emerges from within the creek bed. The microhabitat associated with the spring covers 35 m<sup>2</sup>. Geomorphic diversity is 0.0, based on the Shannon-Weiner diversity index.

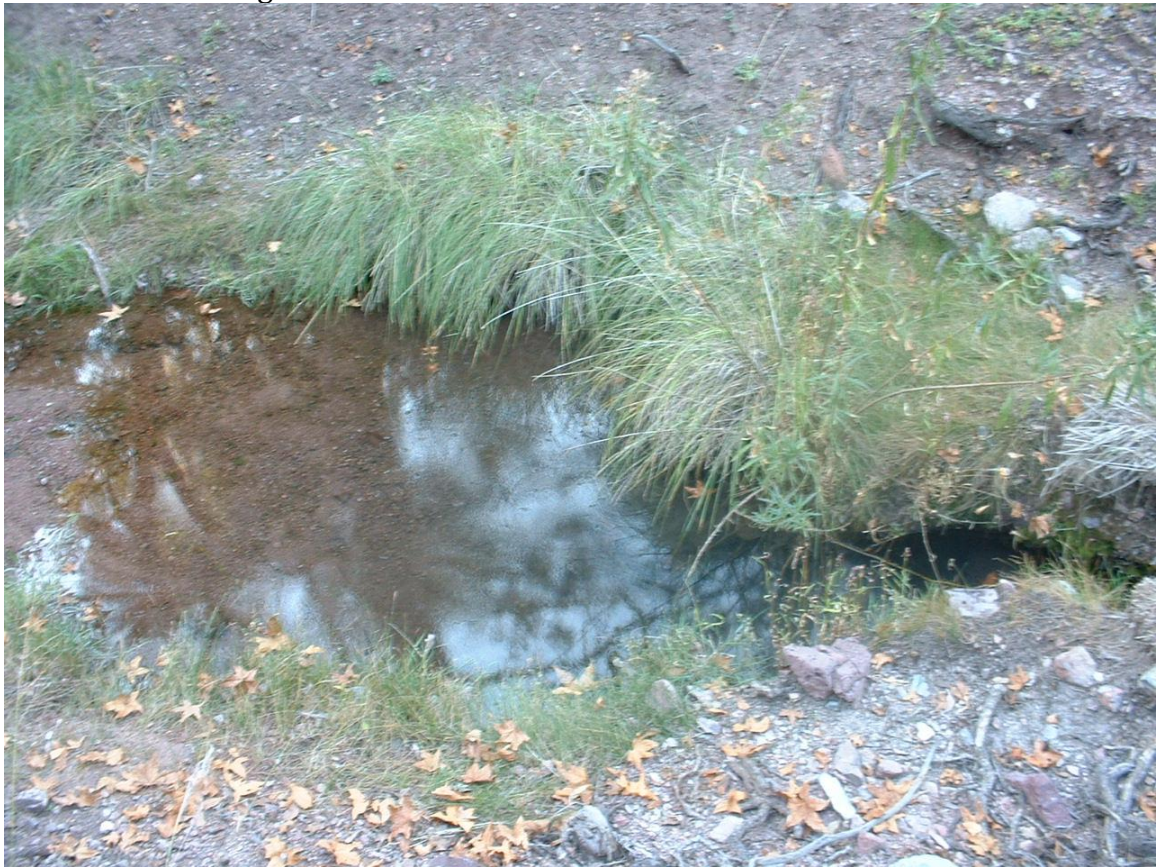
**Fig 53.1 Sycamore Canyon Unnamed Upper.**

**Physical Description:** Sycamore Canyon Unnamed Upper is a rheocrene spring. This rheocrene spring is in a channel in upper Sycamore Canyon with numerous pools and wetland vegetation below the spring emergence. This is a substantial aquatic/wetland habitat site in the Huachuca Mountains. The microhabitat associated with the spring covers 468 m<sup>2</sup>.

**Management Recommendations:** This is a substantial and important wetland habitat in the Huachuca Mountains and cattle should be managed to protect the aquatic and wetland species found here. There were some erosional features that were noticed but it is undetermined if these are part of the natural function of the ecosystem, or they are of management concern. This is a likely site for Chiricahua leopard frog reintroduction. There was migrant traffic at the site and some trash. Small headcuts at the site should be monitored. There were invasive crayfish at the site but it would be difficult to eradicate. We recommend a re-survey for plants.
