# Appendix B: Spring Inventory Reports

## 1. Alamo Spring Survey Summary Report, Site ID 12981

Submitted December 23, 2013 by Sky Island Alliance

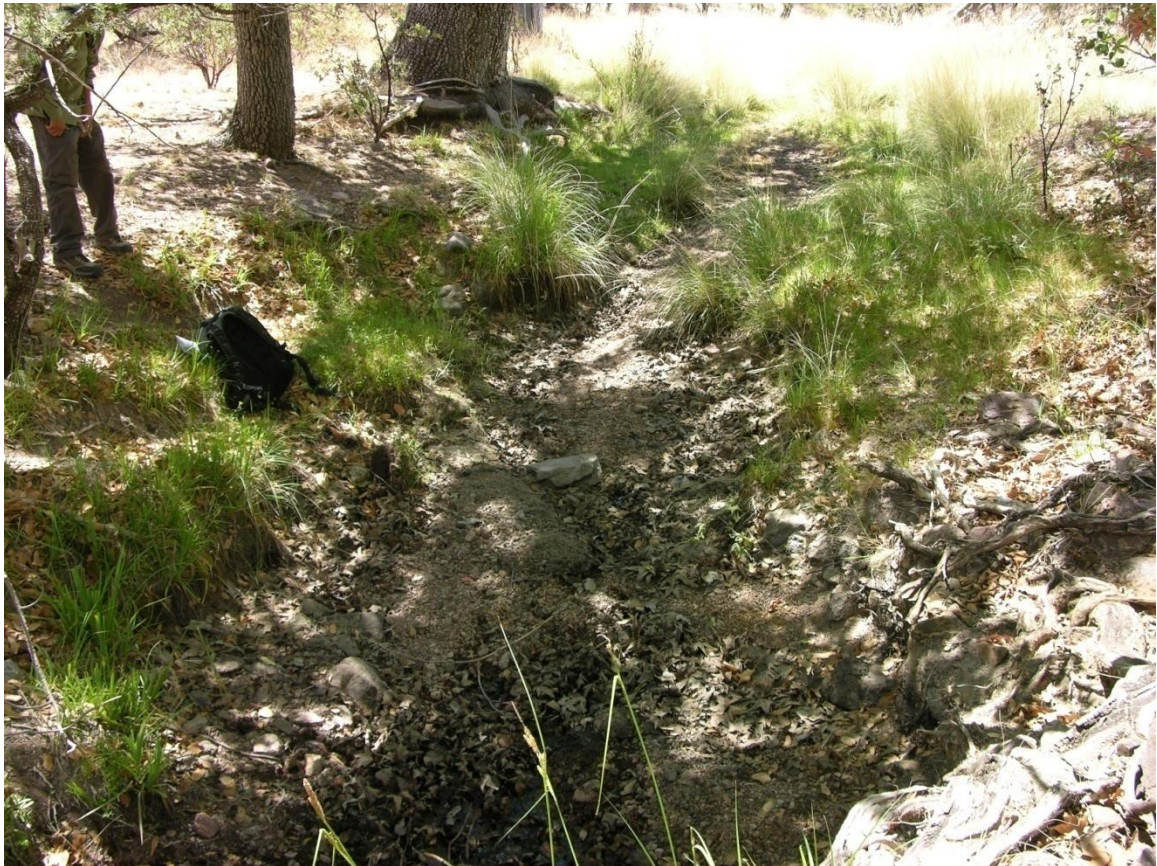
**Fig 54.1 Sycamore Spring.**

**Physical Description:** Sycamore Spring is a rheocrene spring. This is a rheocrene spring that emerges in a side drainage to Sycamore Canyon right next to a large sycamore tree. The mapped location of the spring is downstream from an extensive stretch of perennial water. The microhabitat associated with the spring covers 165 m<sup>2</sup>. Geomorphic diversity is 0.0, based on the Shannon-Weiner diversity index.

**Assessment:** Assessment scores were compiled in 6 categories and 41 subcategories, with 9 null condition scores, and 9 null risk scores. Aquifer functionality and water quality are moderate with some restoration potential and there is low risk.

Geomorphology condition is good with significant restoration potential and there is moderate risk.

Habitat condition is good with significant restoration potential and there is low risk.

Overall, the site condition is good with significant restoration potential and there is low risk.

**Management Recommendations:** At the time of visit this site was heavily impacted by cows. Consider season and other factors in management of this area, and potentially fence cows out. The emergence point of the spring showed significant erosion and downcutting. Depending on management objectives, this erosion should be stabilized to prevent drying of upstream cienega habitat. There is a path that passes close to the spring source. Monitor human use to ensure it does not contribute to further erosion/downcutting.

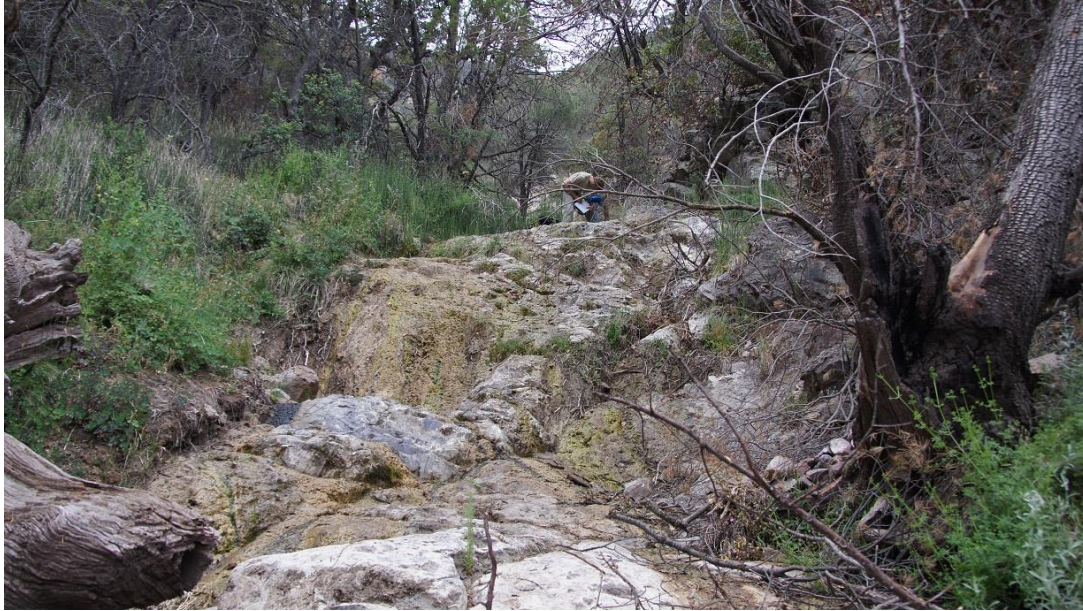
**Fig 56.1 Tunnels Unnamed.**

**Physical Description:** Tunnels Unnamed is a rheocrene spring. This spring is at the top of a steep canyon in a oak woodland. It is .5 km above an abandoned mine, also with water in it. Water seeps from a steep rock face and pools in a 10m x 10m patch of wetland vegetation. The microhabitat associated with the spring covers 117 m<sup>2</sup>.

**Survey Notes:** The site appears to be in good condition. There is evidence of grazing further down in the canyon, but cattle do not appear to reach the upper reaches of the canyon where the spring is.

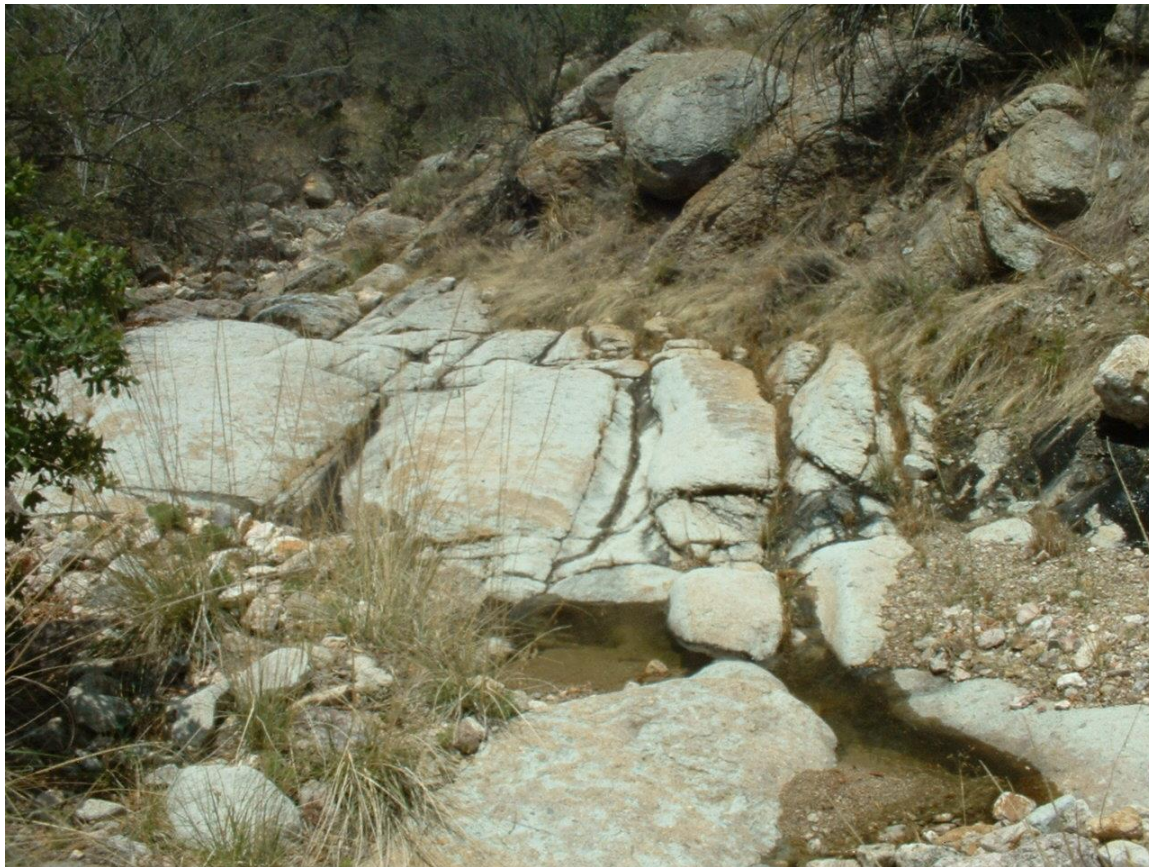
**Fig 58.1 Upper Walker Tank Unnamed.**

**Physical Description:** Upper Walker Tank Unnamed is a rheocrene perennial spring. There is a bedrock channel and a series of pools. Vegetation is limited by the bedrock along water's edge. The microhabitat associated with the spring covers 80 m<sup>2</sup>.

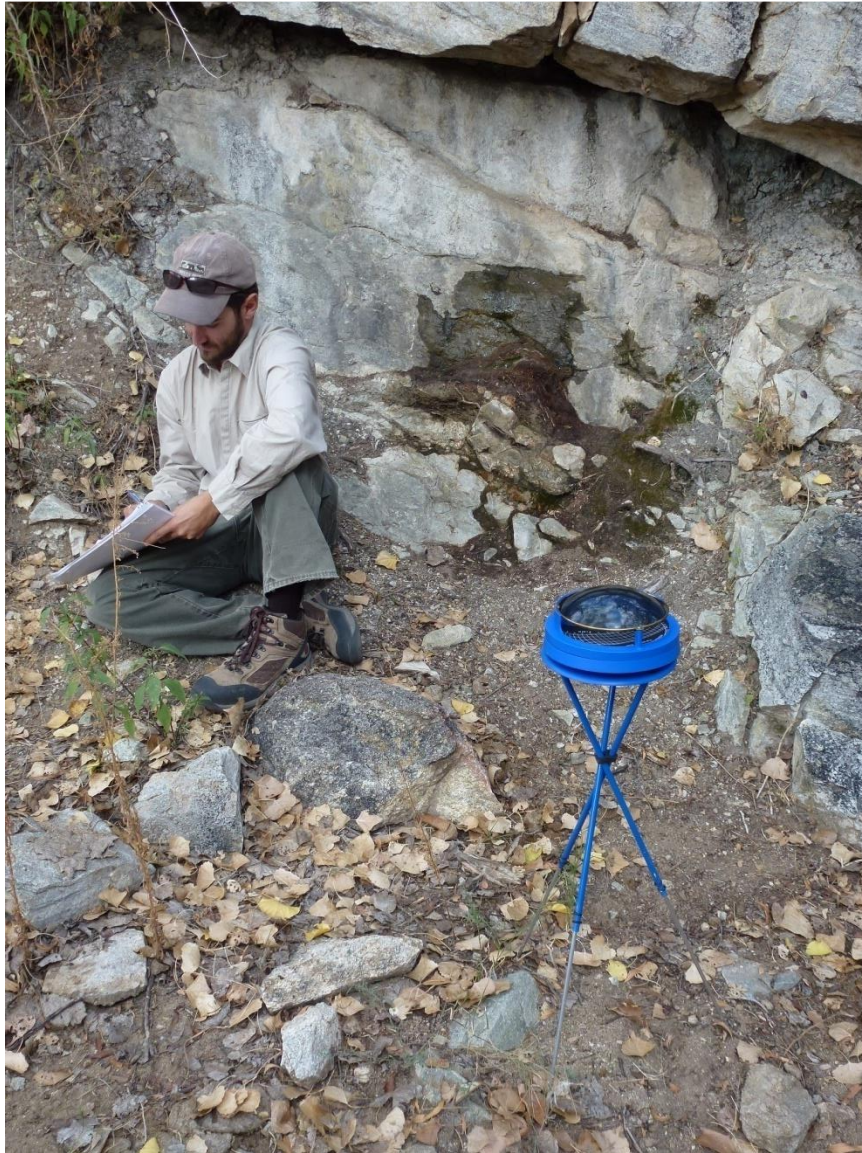
**Fig 59.1 Van Trap Spring.**

**Physical Description:** Van Trap Spring is a hillslope spring. There is a wet spot originating from metamorphic rock in an 80 degree slope. This was the only water present. The microhabitat associated with the spring covers 20 m<sup>2</sup>. Geomorphic diversity is 0.0, based on the Shannon-Weiner diversity index.

**Assessment:** Assessment scores were compiled in 6 categories and 41 subcategories, with 10 null condition scores, and 9 null risk scores. Aquifer functionality and water quality are moderate with some restoration potential and there is low risk.

Geomorphology condition is moderate with some restoration potential and there is low risk.

Habitat condition is moderate with some restoration potential and there is low risk.

Overall, the site condition is moderate with some restoration potential and there is low risk.

**Management Recommendations:** This site did not have any pooled water at the time of assessment, but would benefit from fencing to reduce impacts from herbivory. Site is very difficult to access.

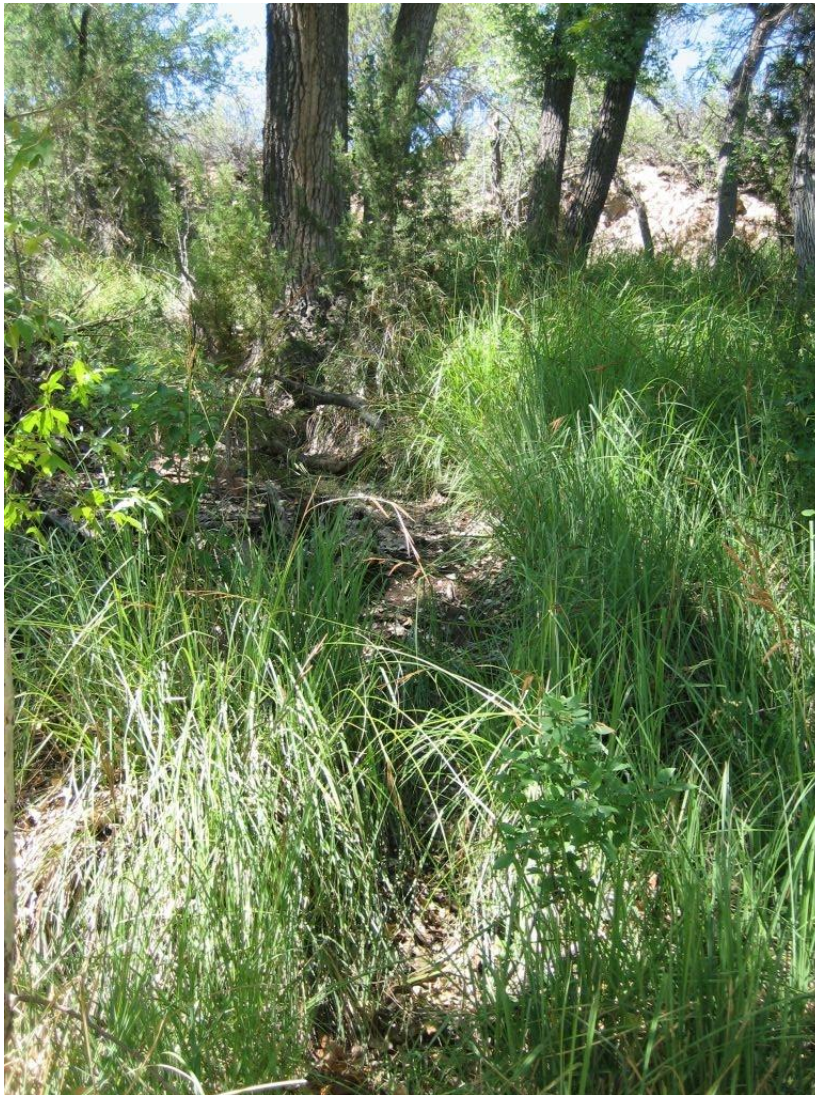
Fig 60.1 Wakefield Spring.

**Physical Description:** Wakefield Spring is a limnocrone spring. This site consists of a cave at the base of the canyon wall and a moist slope covered in *Carex*. The microhabitat associated with the spring covers 5 m<sup>2</sup>. Geomorphic diversity is 0.0, based on the Shannon-Weiner diversity index.

**Assessment:** Assessment scores were compiled in 6 categories and 41 subcategories, with 9 null condition scores, and 9 null risk scores. Aquifer functionality and water quality are moderate with some restoration potential and there is low risk.

Geomorphology condition is good with significant restoration potential and there is low risk.

Habitat condition is good with significant restoration potential and there is low risk.

Overall, the site condition is good with significant restoration potential and there is low risk.

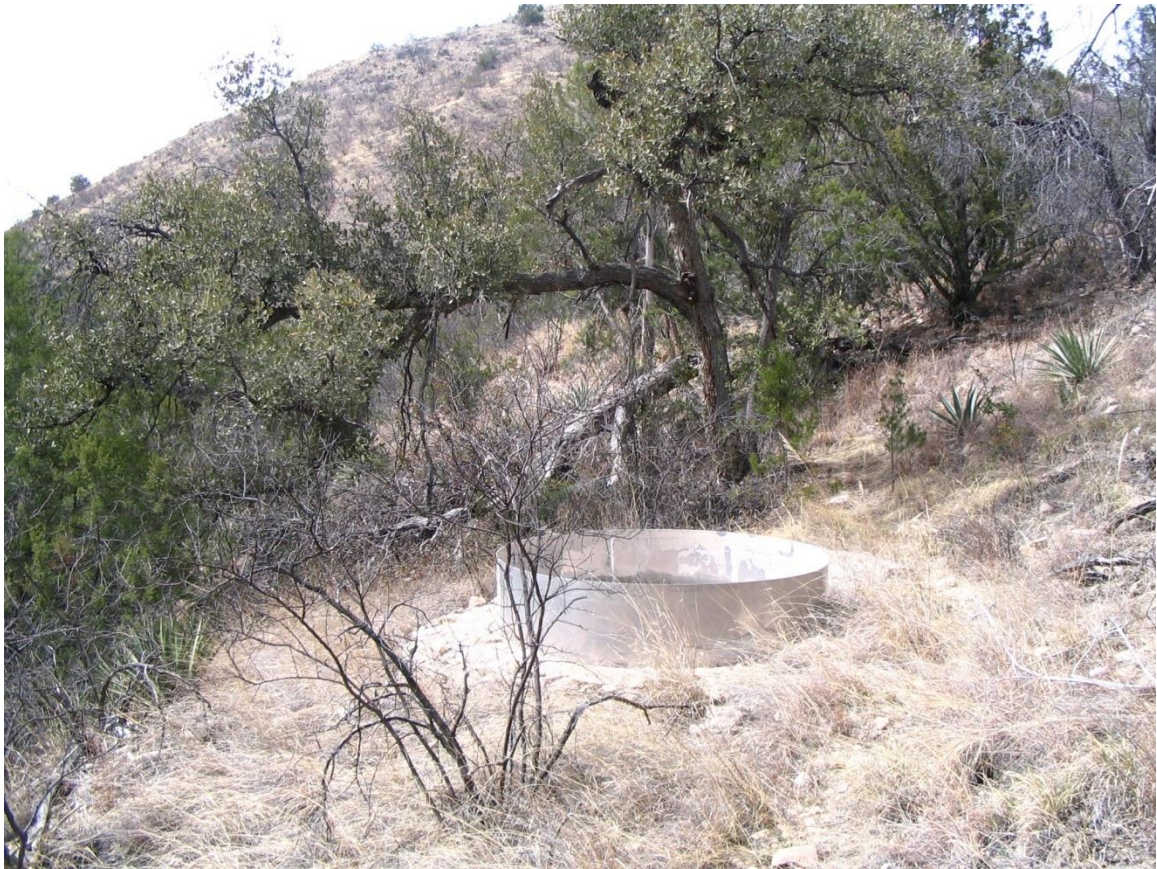
**Fig 62.1 Willow Spring.**

**Physical Description:** Willow Spring is a rheocrene spring. It is a heavily developed site in an oak woodland canyon. All water emerges from a pipe. There are lots of unused pipes and a 1 meter diameter dry tank. The microhabitat associated with the spring covers 885 m<sup>2</sup>. Geomorphic diversity is 0.17, based on the Shannon-Weiner diversity index.

**Assessment:** Assessment scores were compiled in 6 categories and 41 subcategories, with 11 null condition scores, and 12 null risk scores. Aquifer functionality and water quality are poor with limited restoration potential and there is moderate risk.

Geomorphology condition is poor with limited restoration potential and there is moderate risk.

Habitat condition is poor with limited restoration potential and there is moderate risk.

Overall, the site condition is poor with limited restoration potential and there is moderate risk.

**Management Recommendations:** There are dead willows at the spring source. The source had been fenced and at this point is now in disrepair.

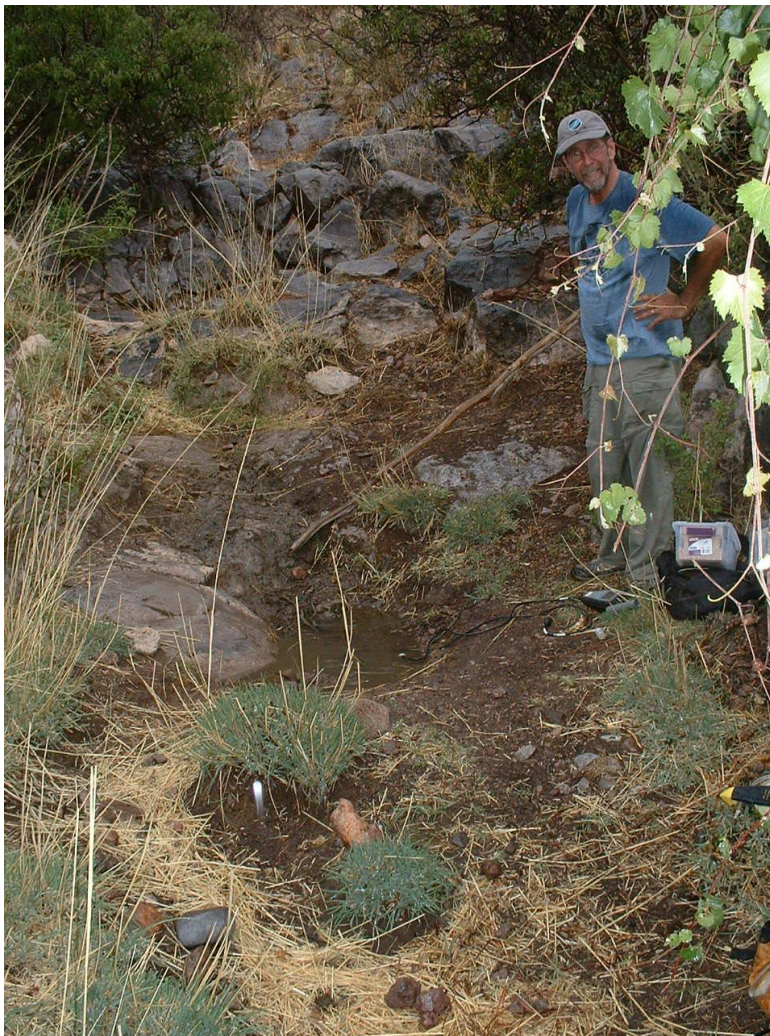
Fig 63.1 Yaqui Spring.

**Physical Description:** Yaqui Spring is a rheocrene spring. This site is a small pool with little vegetation. The microhabitat associated with the spring covers 1 m<sup>2</sup>. The site has 1 microhabitat, A -- a 1 sqm pool.
